## **Vertiefte Untersuchungen zum hochenergetischen Versagen elektrischer Komponenten (HEAF) mit möglicher Brandfolge**

Marina Röwekamp

November 2015

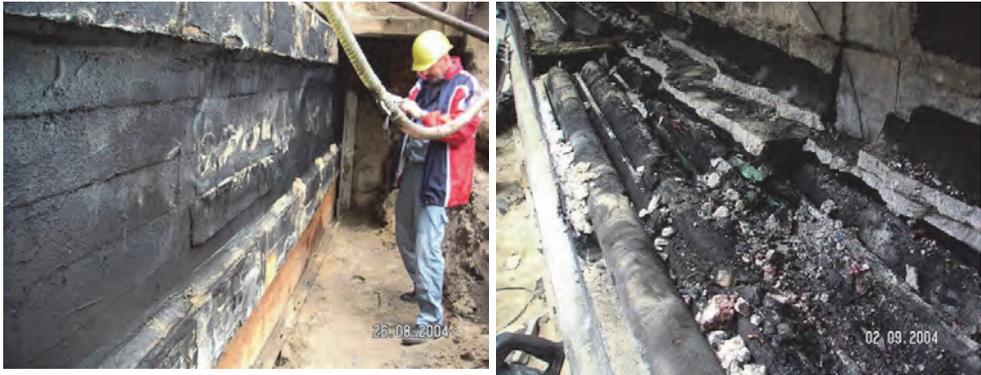
Fig. 3. Photos of the cable damage; left: location of the damaged cable, right: damage by the cable fire/evaporation

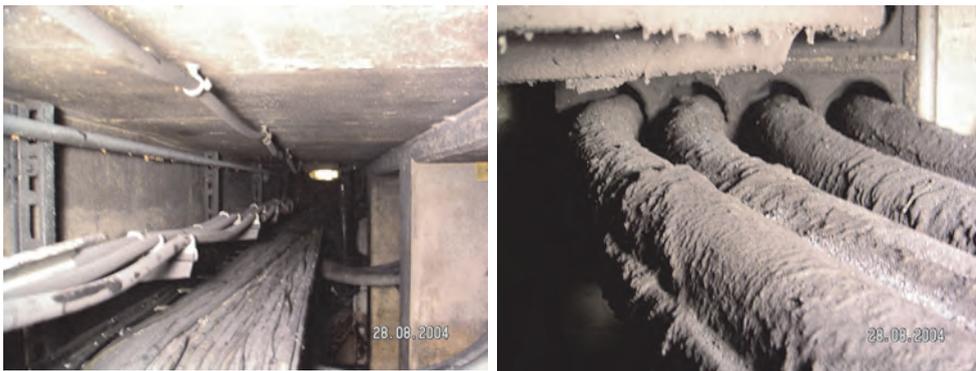
Fig. 4. Cables with protection by intumescent coating; left: photo of the cable channel, right: photo of the coating

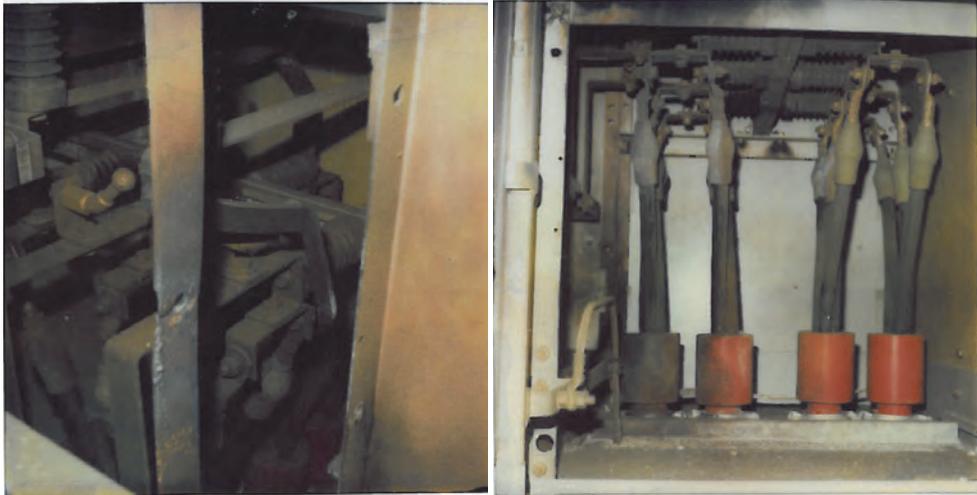
Fig. 5. Photographs: a) view into the exciter cabinet, in the foreground location where the screw loosened and b) view into the cabinet

Performing a load test during a regular in-service inspection (usually at an interval of four weeks) of the emergency diesel generator, an arcing fault with a short-to-ground took place in the electrical cabinet of the exciter system of the emergency diesel generator (cf. Figure 5 above).

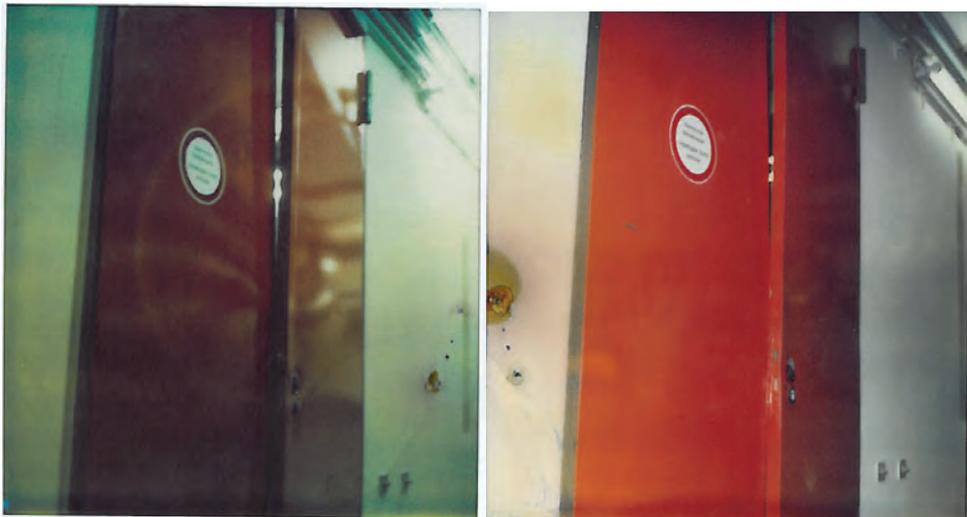
Fig. 6. Photographs of the damaged fire door from outside the room

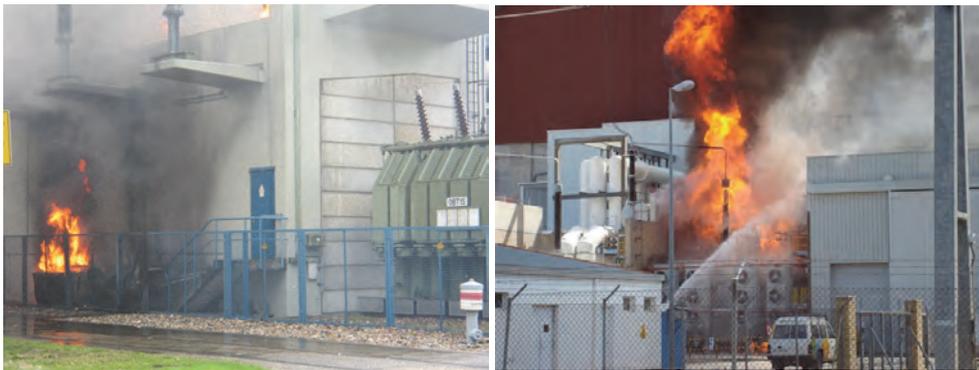
Fig. 8. Flame and smoke occurring at the generator transformer; the photo on the right hand shows the fire extinguishing activities

As a consequence of these indications, improvements concerning the fire protection of transformers are intended in Germany (Berg et al., 2010).

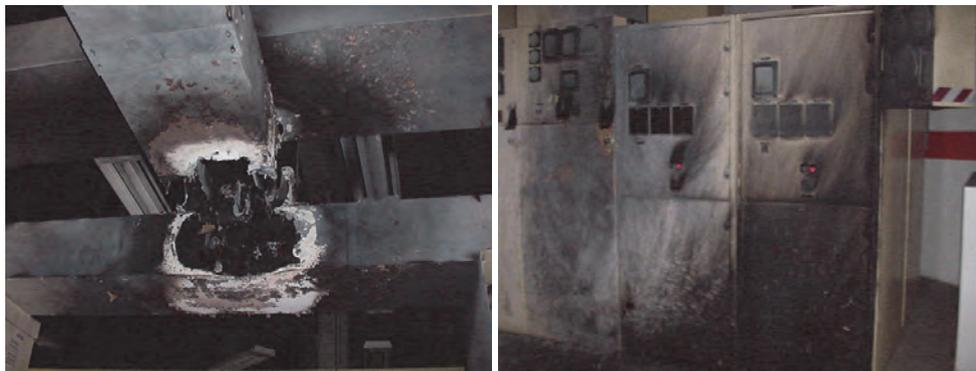
This event was initiated due to the centre bus overheating causing the polyvinyl chloride (PVC) insulation to smoke, which led to a failure of the adjacent bus insulation. Having only a thin layer of silver plating on the electrodes, noticeably flaking off in areas not directly affected by the arc, contributed to the high-energetic arcing fault event.

Other factors that caused the failure were heavy bus loading and splice joint configurations, torque relaxation, and undetected damage from a 1995 transformer explosion. Two photos of this failure are shown in Figure 9. More photos are provided in (Brown et al, 2009).

Fig. 9. Photographs of the damages at the Diablo Canyon nuclear power plant (from Brown et al., 2009)

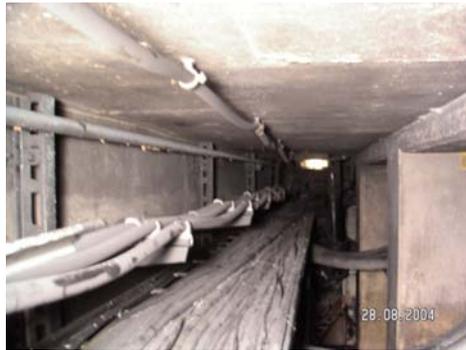
Cable channel with fire protected cables

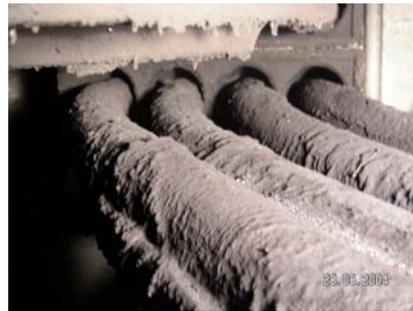
Protective cable coating with soot damage

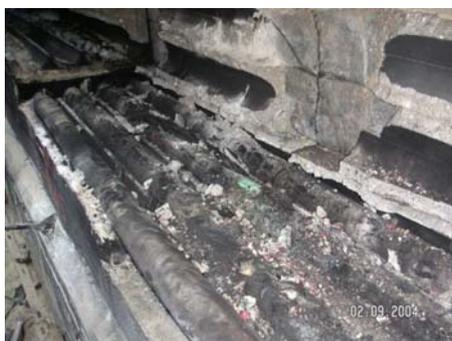
Damage by the cable fire / evaporation

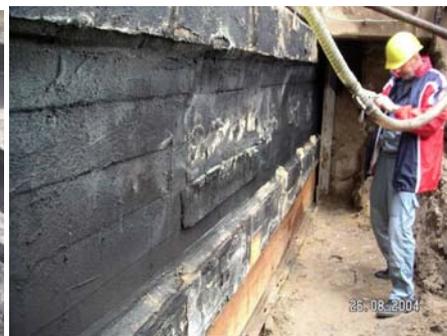
Location of the damaged cable after opening

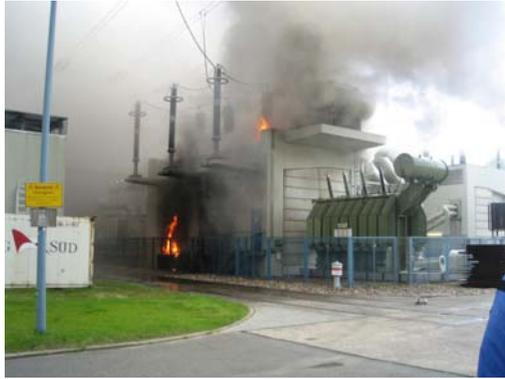
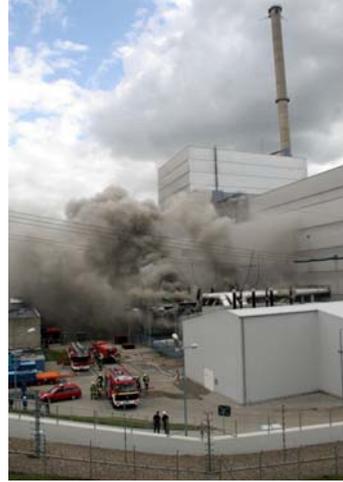
The transformer is on fire

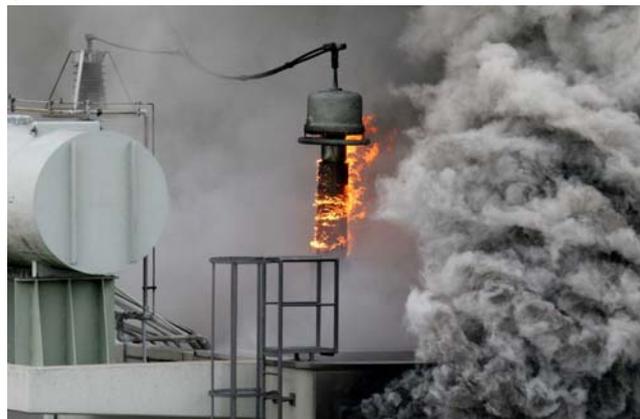
Surge arrester is on fire

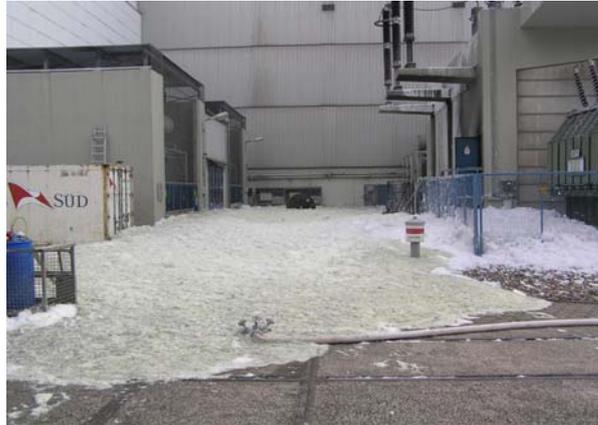
Extinguishing foam left after the event

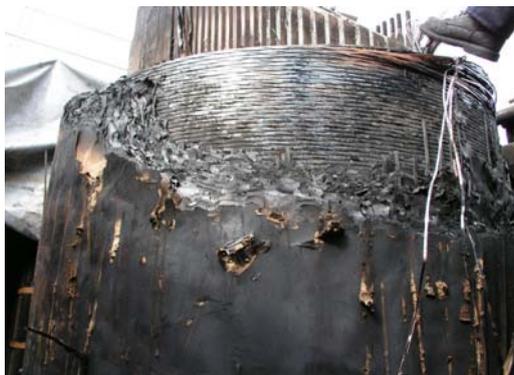
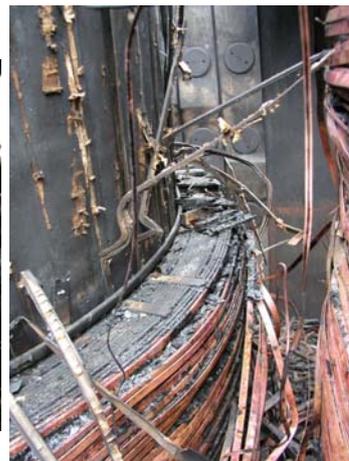
Damaged transformer windings with insulation burned
