# Retables on the Croatian Island Lopud

Construction – Polychromy – Restoration

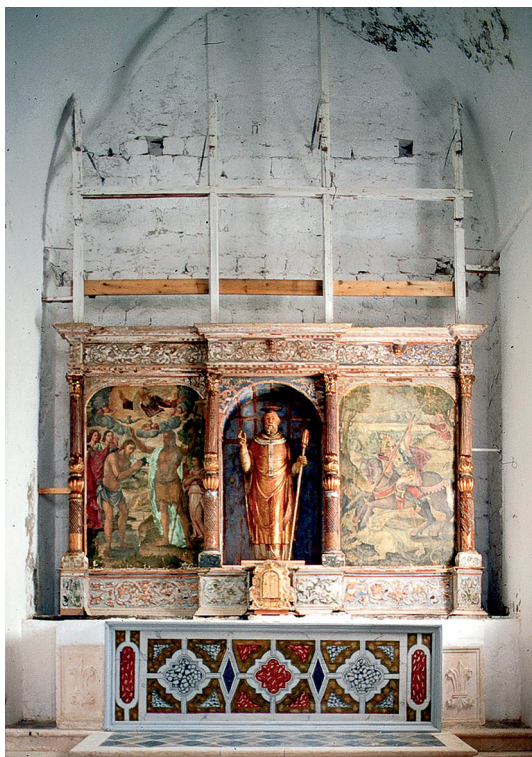
Fig. 3: Retable before treatment

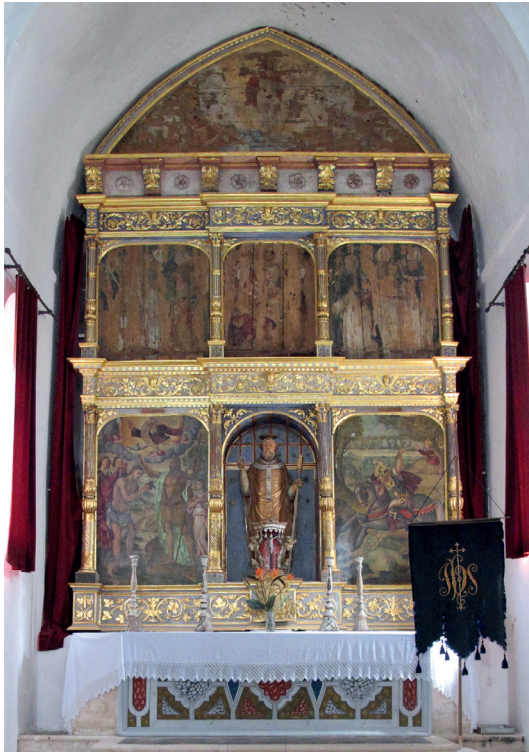
Fig. 4: Lopud, former Dominican monastery church of St Nicholas; retable after treatment; H: 7,25 m

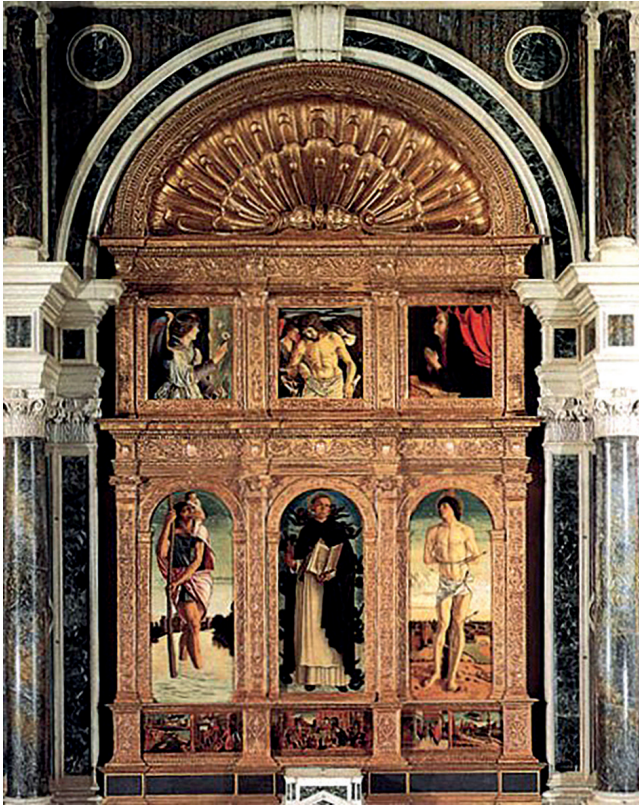
Fig. 5: Venice, Basilica dei Santi Giovanni e Paolo, Polyptych of San Vincenzo Ferreri: Giovanni Bellini (1464-70)<sup>9</sup>; H: 2,75 m

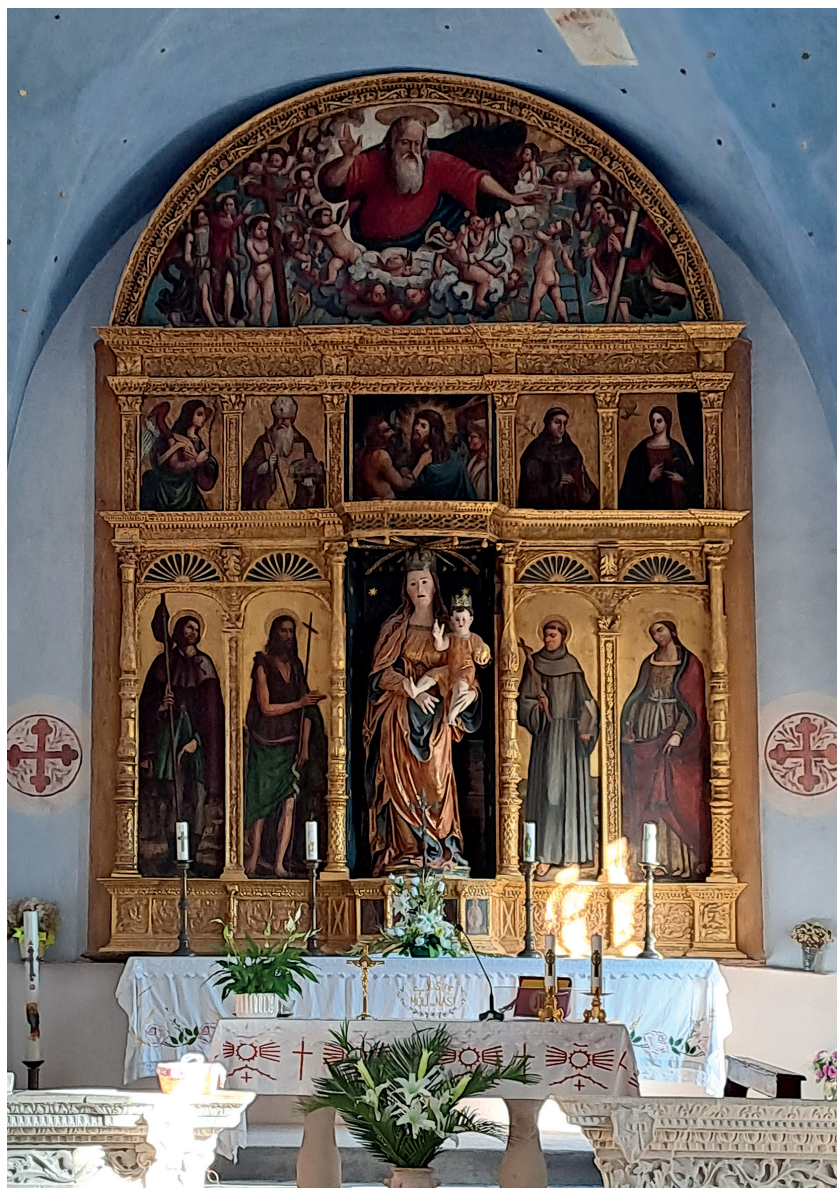
Fig. 6: Lopud, former Franciscan monastery church Sv. Marija od Špilice, main retable: Pietro di Giovanni<sup>10</sup>; about 1523; H: 5,40 m

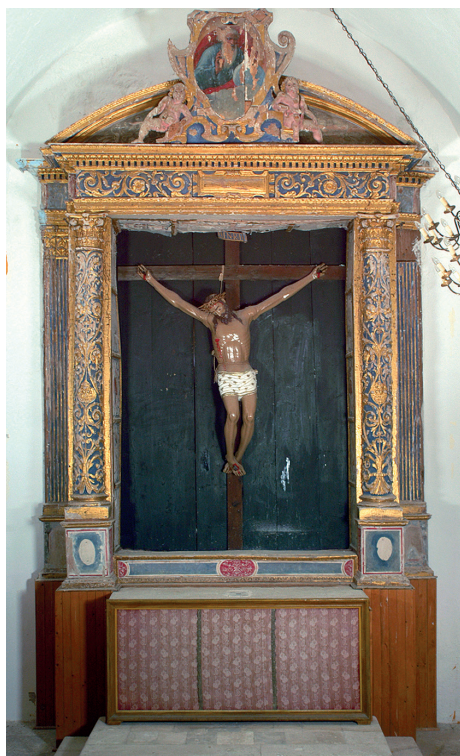
Fig. 8: Holy Cross retable, before treatment

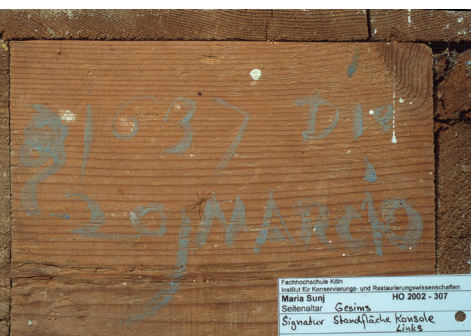
Fig. 12: Inscription underneath the entablature: “1637 dio 20 marcio”

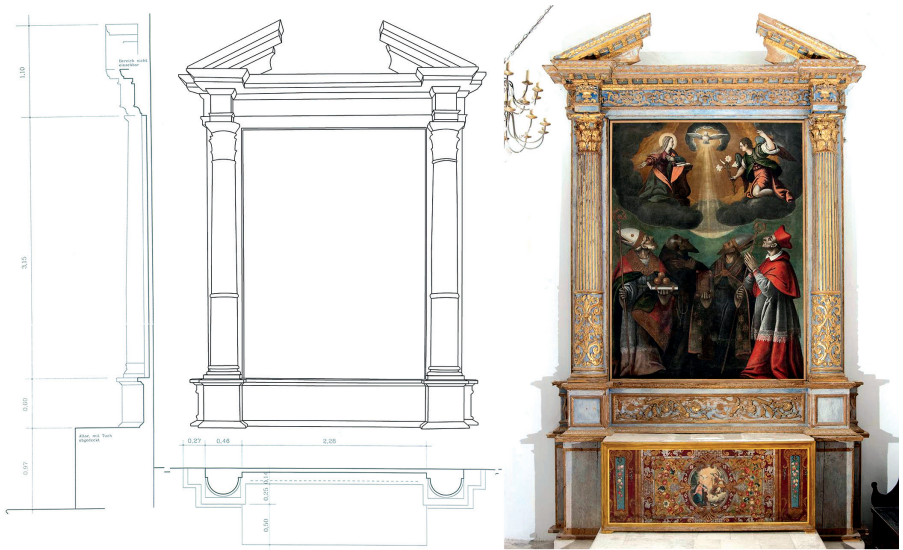
Fig. 15: Annunciation retable, measurement; H: 6,28 m

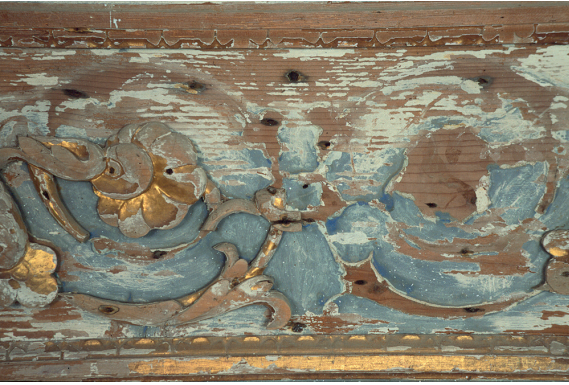
Fig. 16: Front of predella, detail; condition before treatment

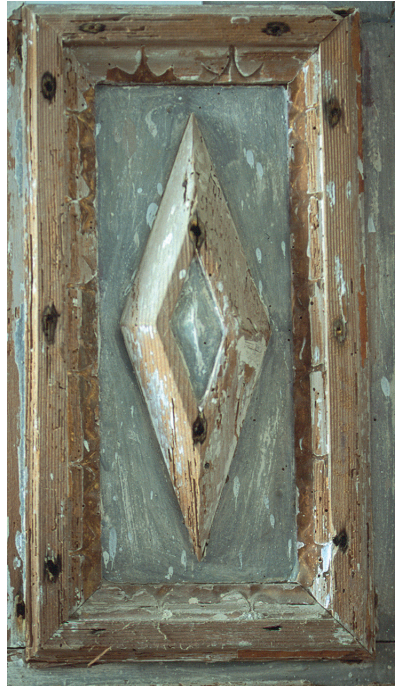
Fig. 17: Lozenge at the projecting side of the predella; condition before treatment

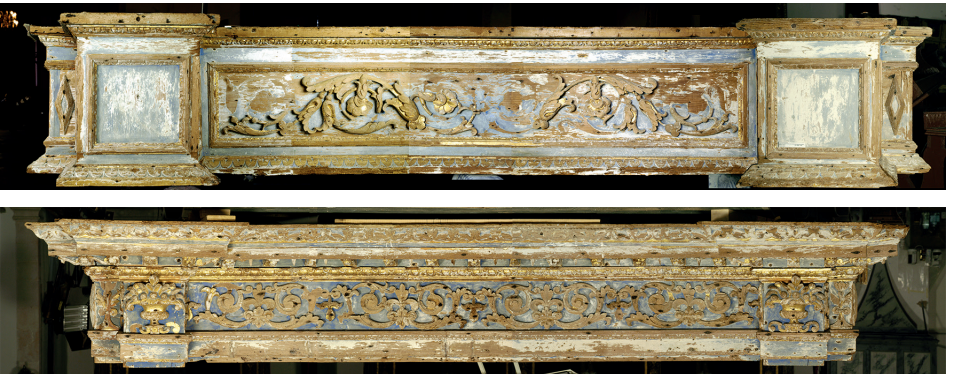
Fig. 18: Complete view of entablature and predella; condition before treatment (digital composite)

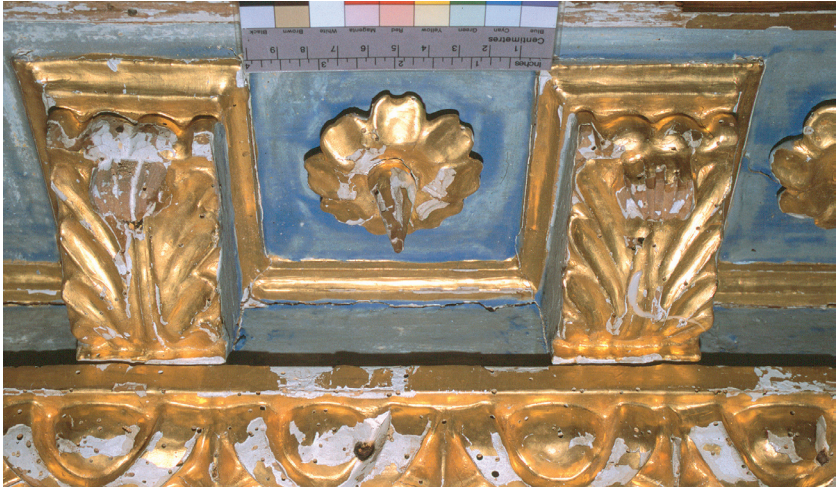
Fig. 19: Detail of the entablatura, compare Fig. 20

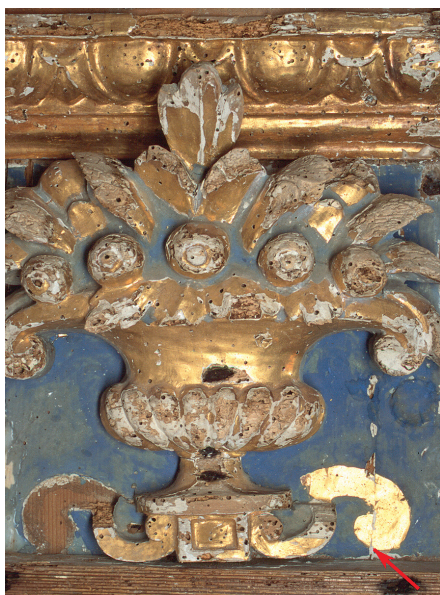
Fig. 25: Even before gilding, the lower right volute had broken off. Here, the gilding lies on the flat support (condition before treatment). The blue paint has a patchy, irregular appearance

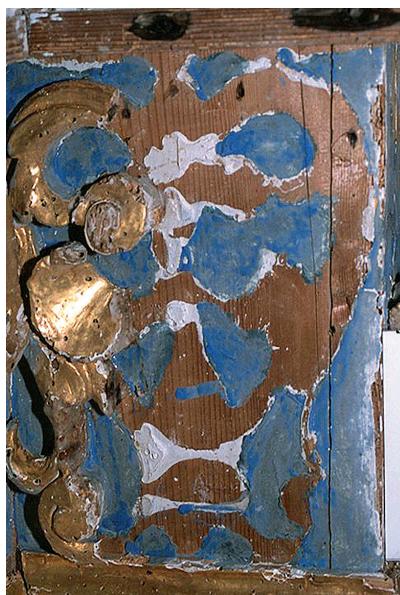
Fig. 26: Detail of the frieze; drops of preparation and colour that had run behind the applied ornamentation are now visible due to the loss of the carving. The horizontal orientation makes it clear that the gilding and polychroming took place before the individual elements were assembled

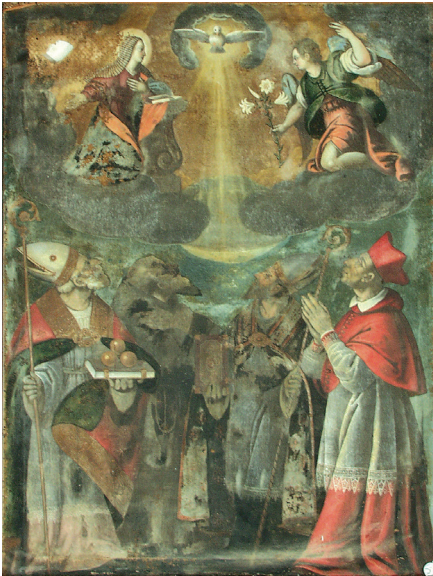
Fig. 27: Painting "Annunciation"; condition as found

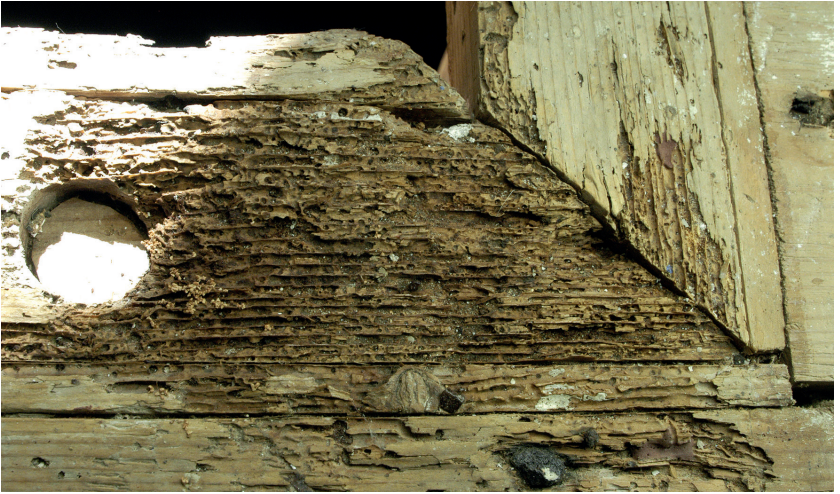
Fig. 31: Predella, detail; damage due to insect attack

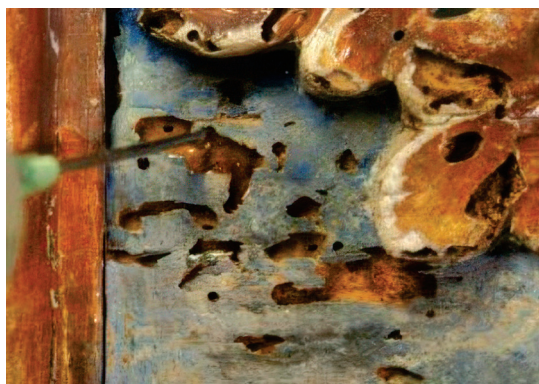
Fig. 33: Injection of *Plexigum* consolidant

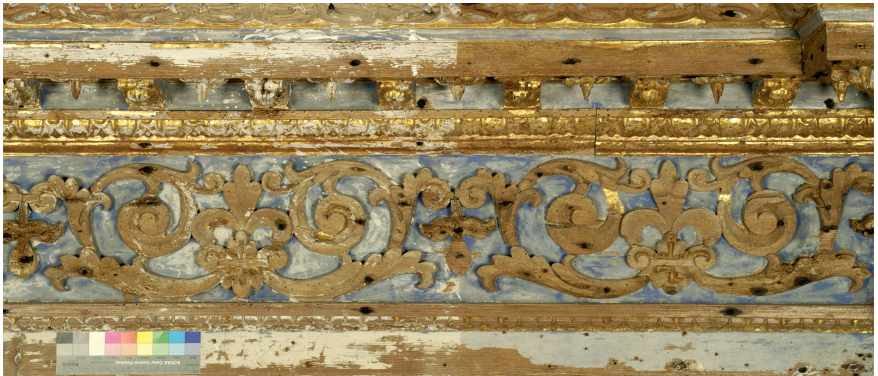
Fig.34: Entablature; test area for the retouching concept; left side untreated / right with retouches

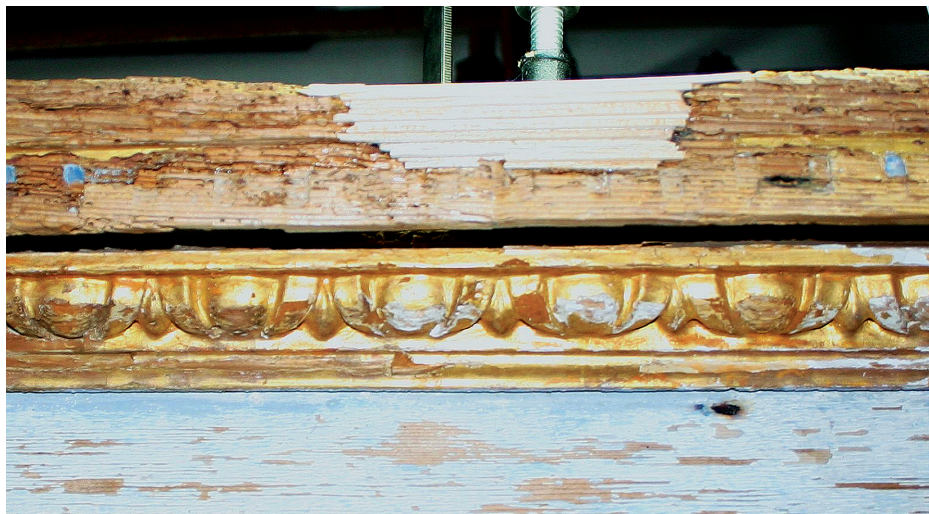
Fig. 35: Predella, reconstruction of moulding with subsequently added wood-sticks, before shaping and retouching

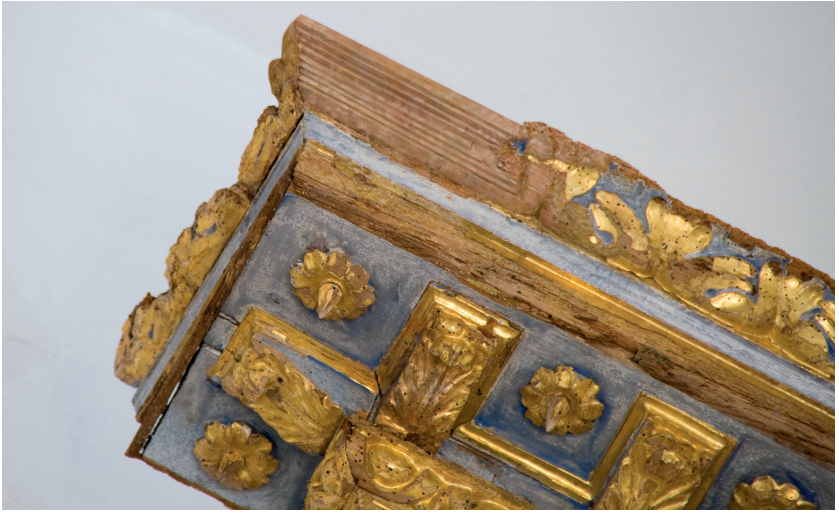
Fig.36: Right gable; reconstruction of the broken corner

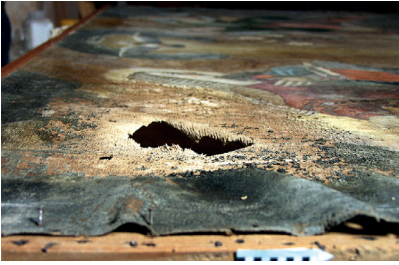
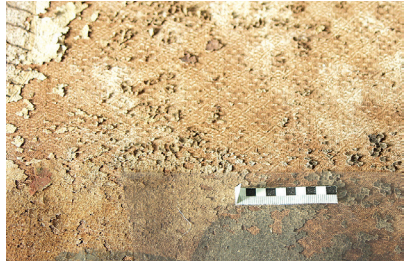
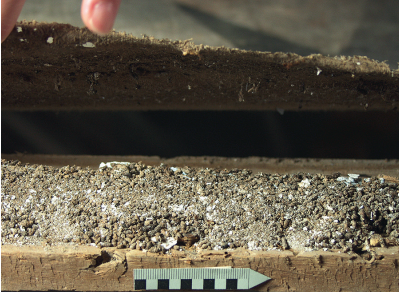
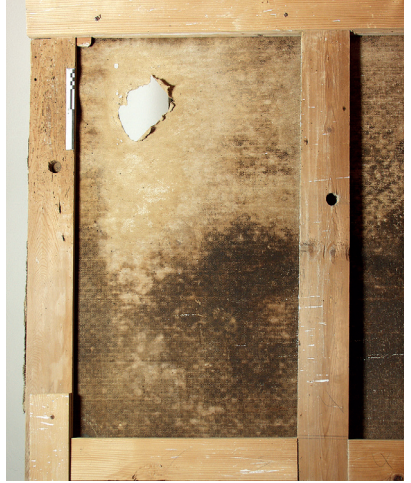
Fig. 46-49: Damage to the painting caused by bats; the hole in the upper left corner was used by bats as an entrance to their roost; the droppings caused severe cupping of the paint layer, deformation, and bleaching of the canvas

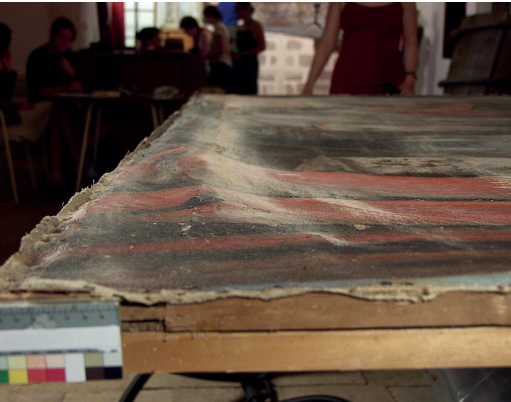
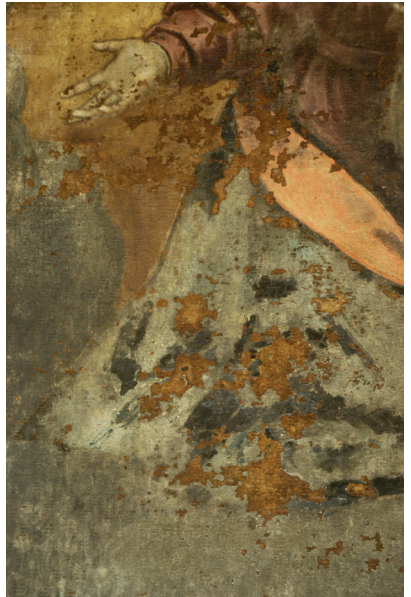
Fig. 50: The bottom of the painting was deformed through the weight of the large format. The surface is covered by dust and dirt. (position on the working table)

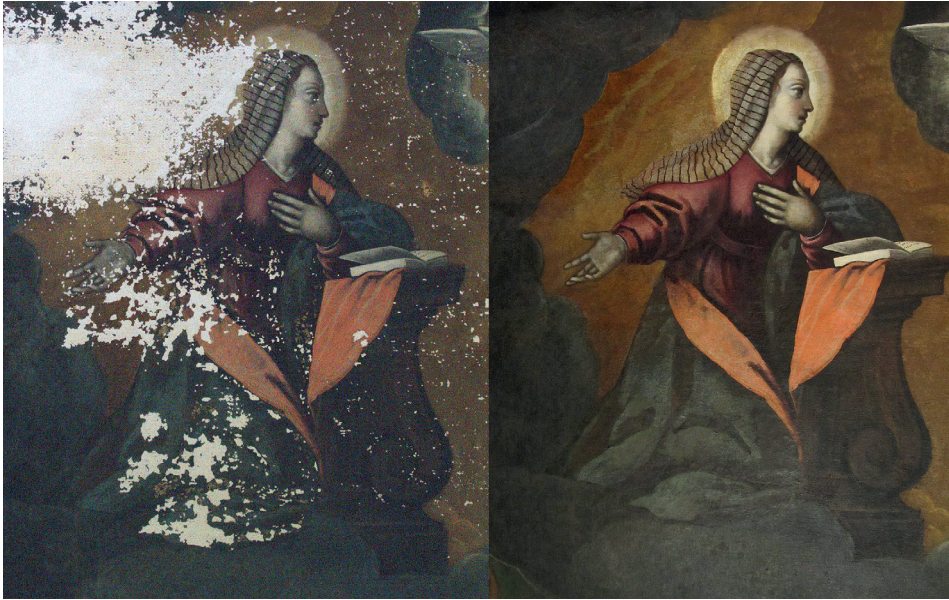
Fig. 60, 61: The area of the “bat hole” after filling and after retouching

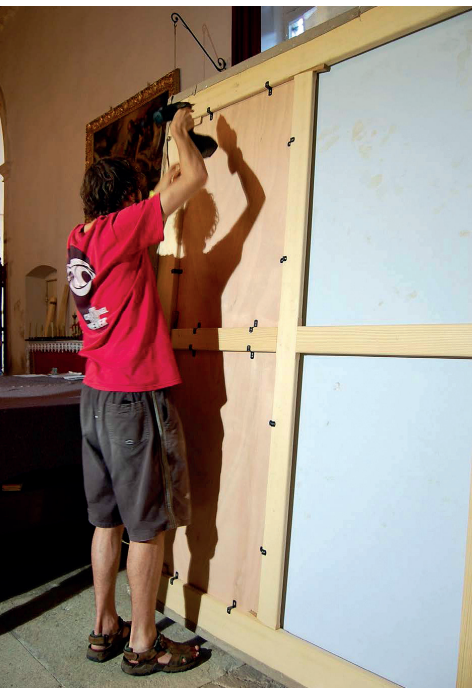
Fig. 62: Installation of the rigid backing; the polyester loose-lining is visible in the right-hand spaces between the bars of the new stretcher

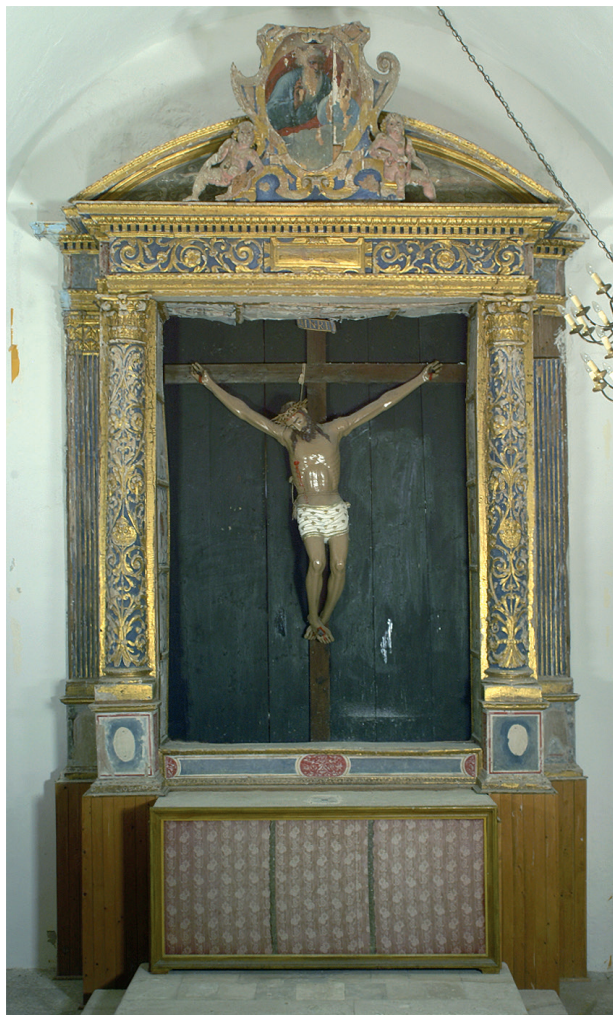
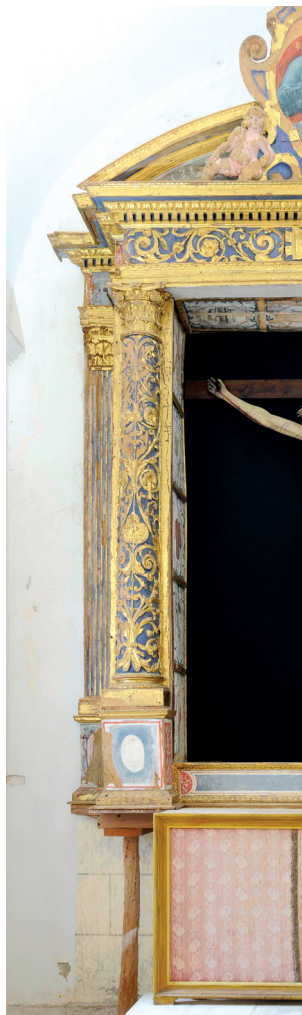
carved on the stone arch of the chapel: “*Hoc tibi dive Roche Thomas Pidelli condidit sacellum 1527.*” (To You, St Roch, Thomas Pidelli erected this chapel in 1527.). The statue of St Roch, originally on the altar of the chapel, was later replaced by the wooden polychrome retable with the Crucifix and the chapel has been called the chapel of the Holy Cross ever since.<sup>43</sup> It is worth mentioning that there is a small rosette window in the north wall, now hidden behind the Holy Cross retable that must, however, have been visible in earlier times.

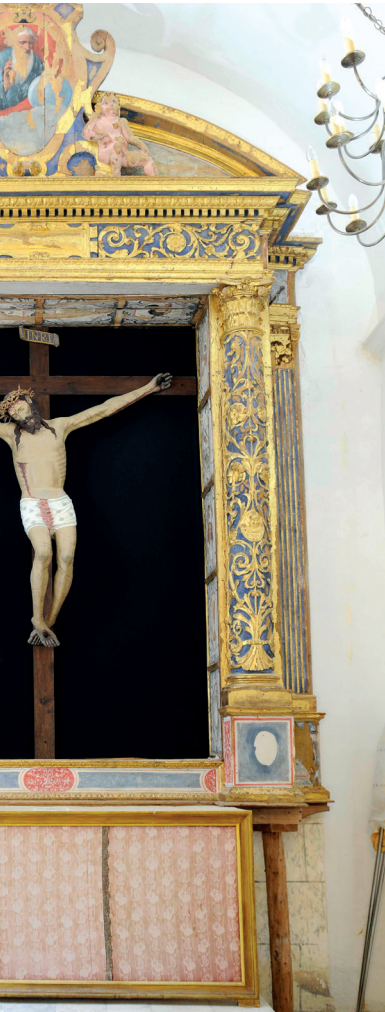
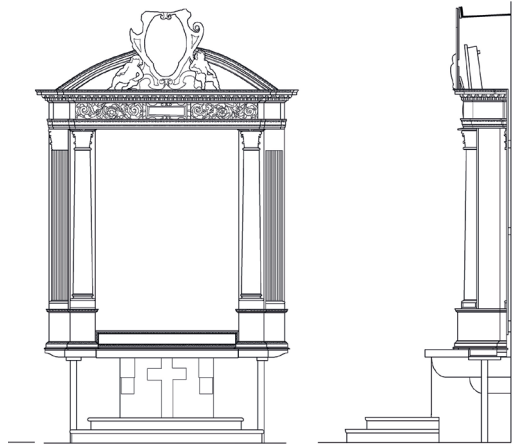
Fig. 66: Holy Cross retable; condition as found

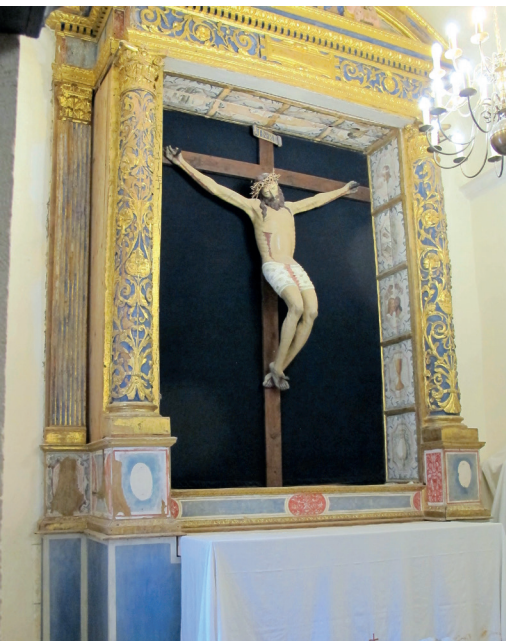
Fig. 70: Holy Cross retable seen from the side; condition after treatment

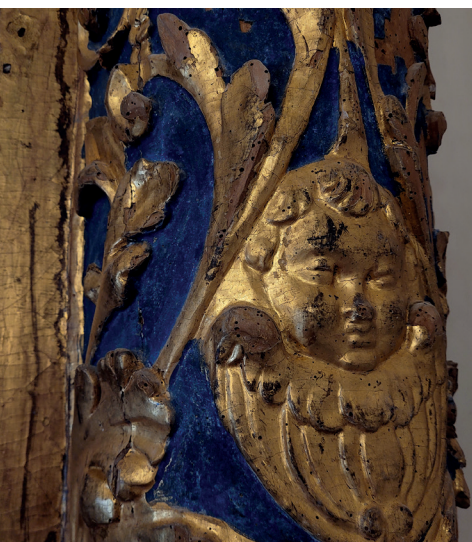
Fig. 71: Central motif of the columns

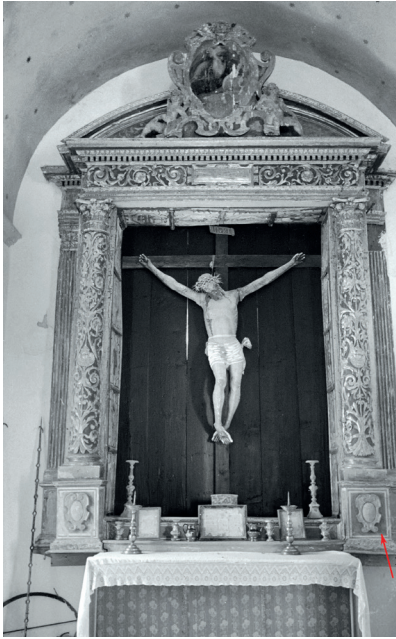
Fig. 73: About 1950; small cartouches on the front of the postaments are missing today; the retable has no lateral pedestals (with permission by the photo archive of the monument care office, Split).

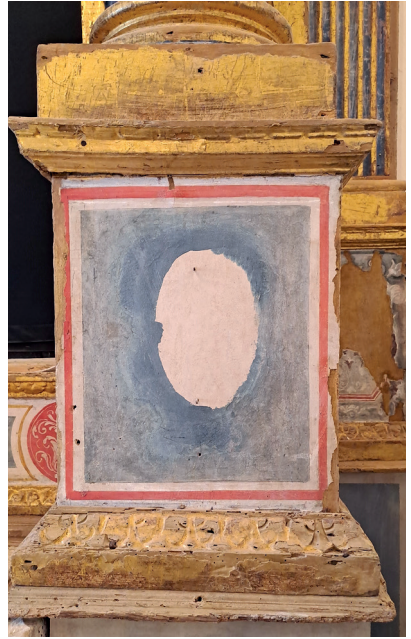
Fig. 74: Right postament; empty position of former attached cartouche

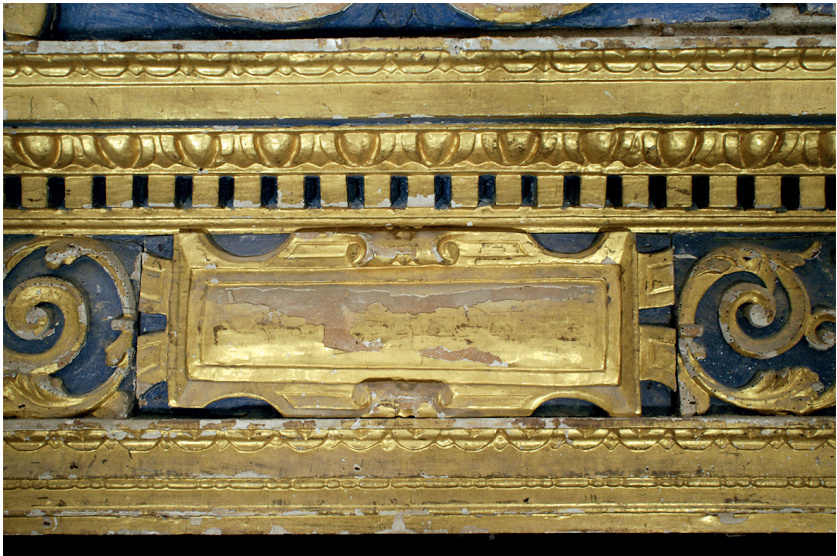
Fig. 76: Central area of the architrave with the cartouche in the frieze, condition as found

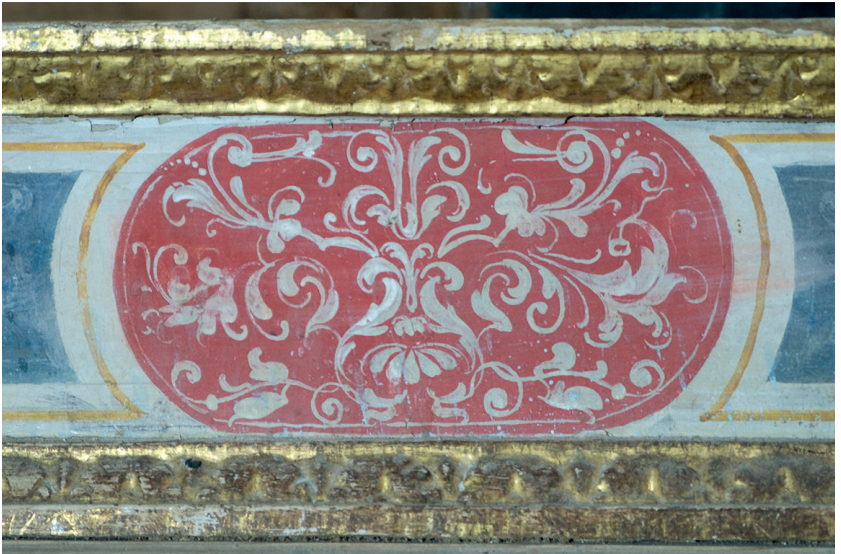
Fig. 77: Central motif of the predella; condition as found

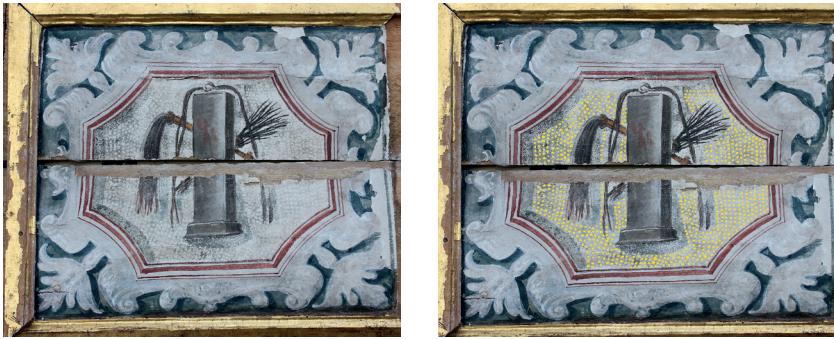
Fig. 78, 79: Arma Christi; detail with the symbols of the flagellation; (left) white dots in the background of the inner cartouche indicate the position of lost gold dots that had been gilded with mordant gilding; the gilding is lost except for microscopic traces; white preparation layer is now visible; (right) digital reconstruction of the lost gold-dotted background decoration

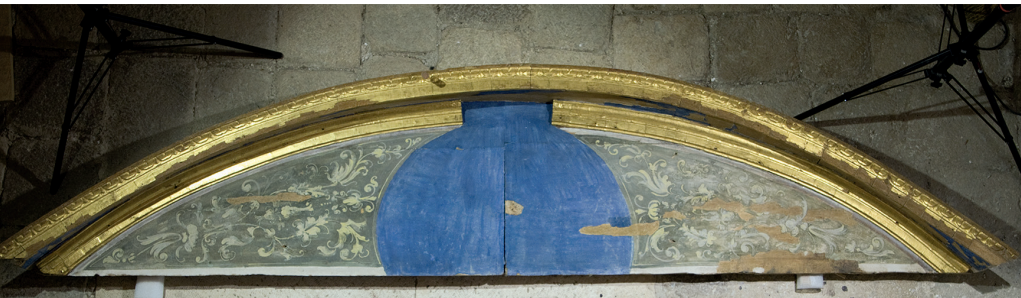
Fig. 80: Pediment with blue circle hidden behind the cartouche (here removed), condition as found

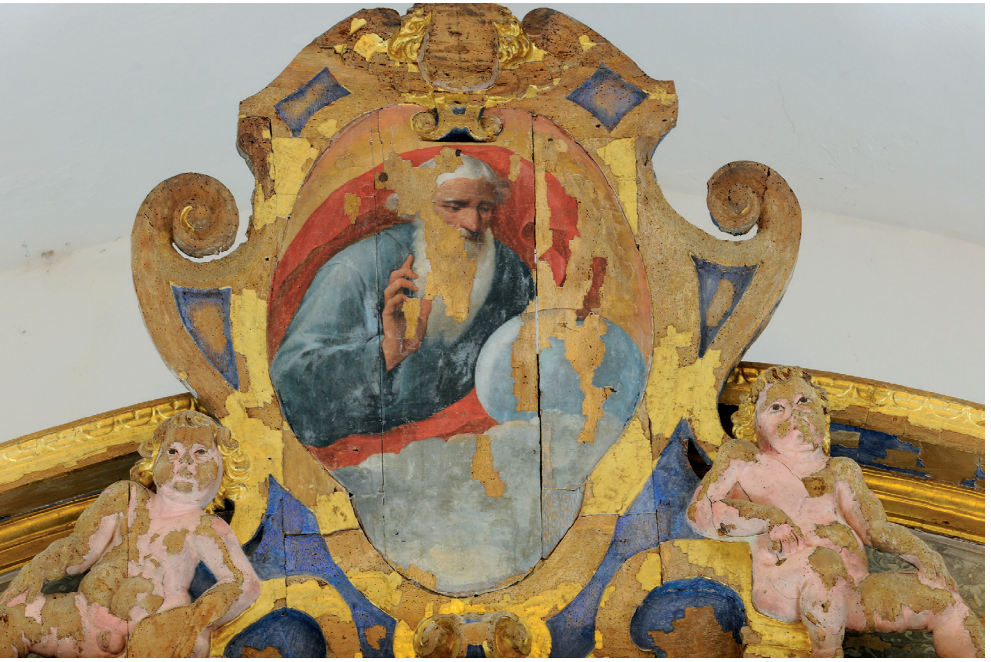
Fig. 81: Cartouche “God Father”; condition after conservation

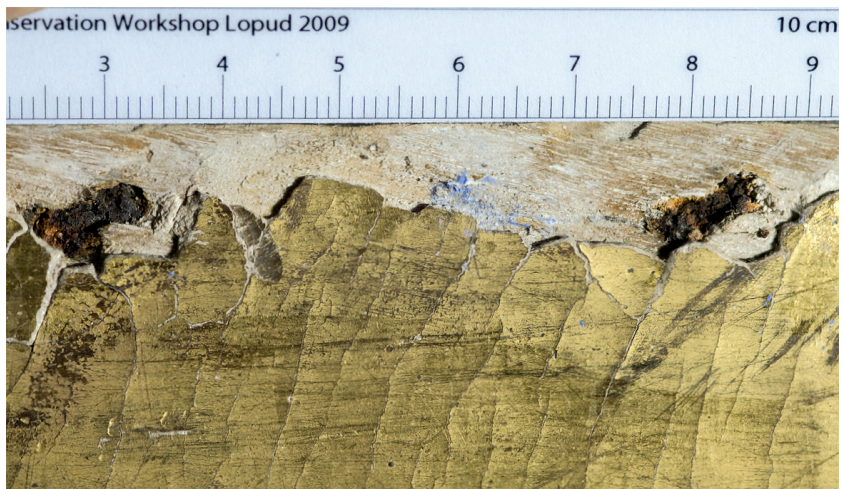
Fig. 83: Detail of the gilding; condition before treatment. The loss in the gilding shows the nail heads, which had been covered by preparation and gilding

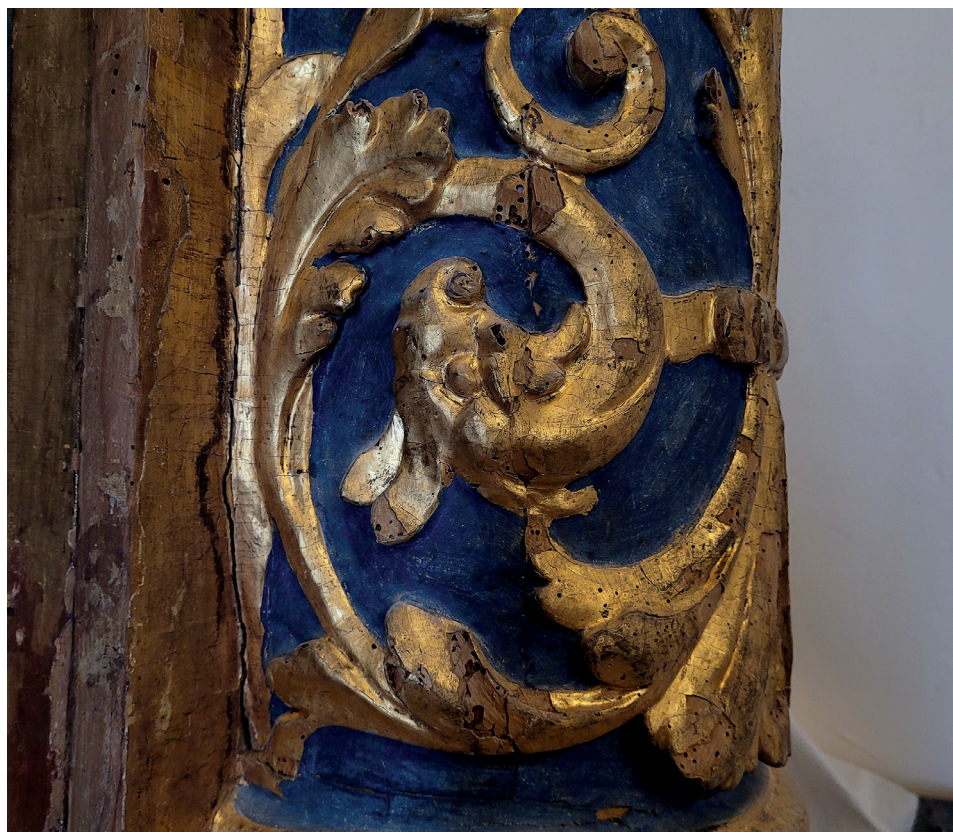
Fig. 85: Detail of the right column; dark blue smalt is contrasting the gilded ornaments

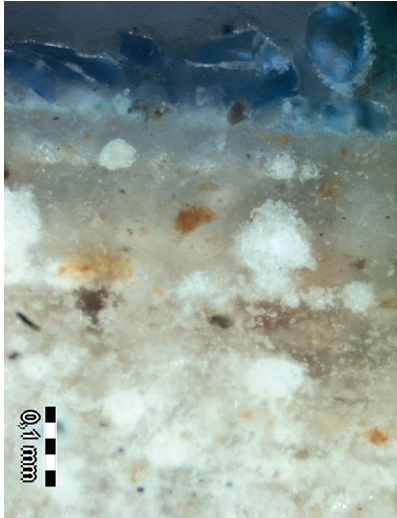
Fig. 84: Cross-section through blue area; coarse smalt particles on multilayered preparation

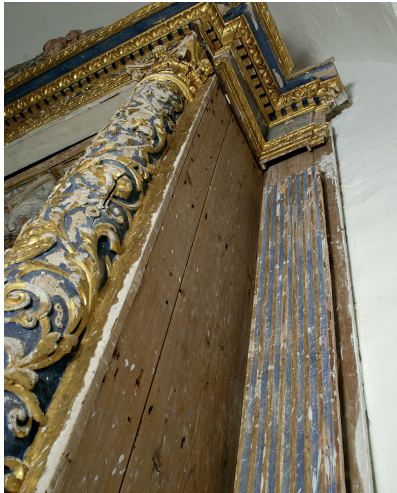
Fig. 89: Bare wood on the side of the retable; condition as found

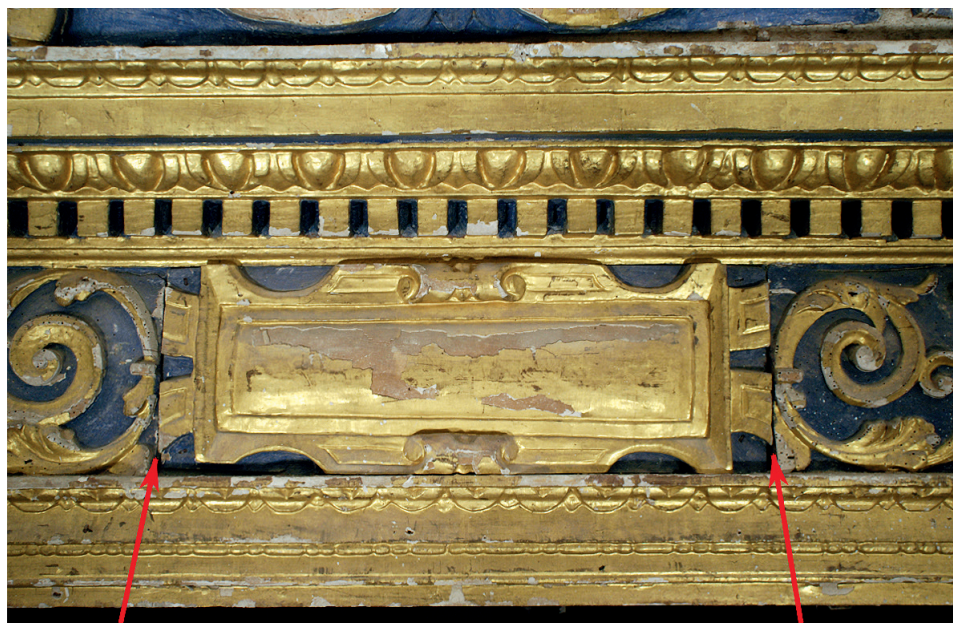
Fig. 90: The central cartouche was cut on both sides after the finishing of the gilding

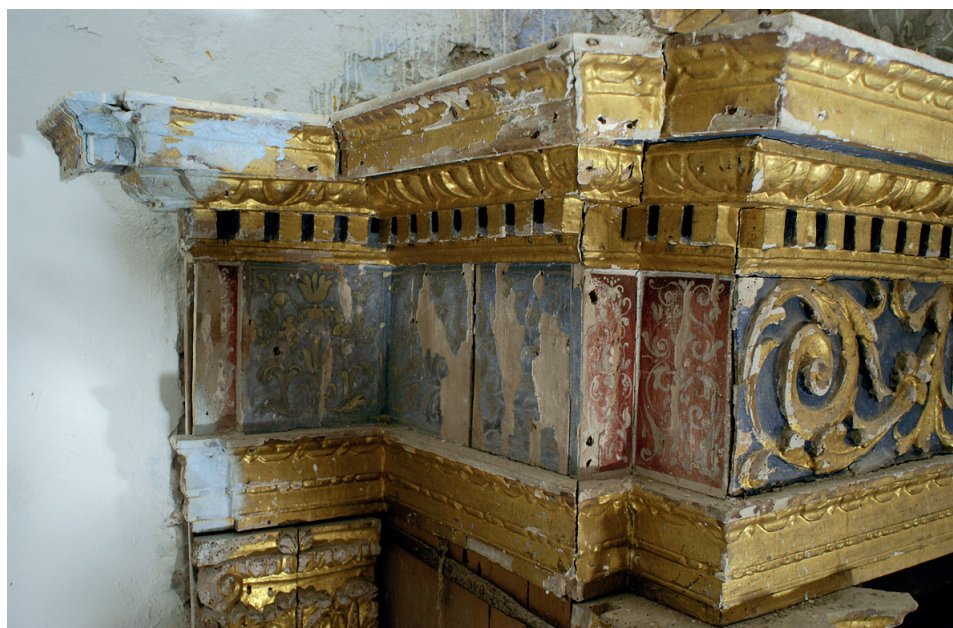
Fig. 91: Holy Cross retable; left part of the entablatura, condition as found; white paint splashes from the wallwashing on the gilding

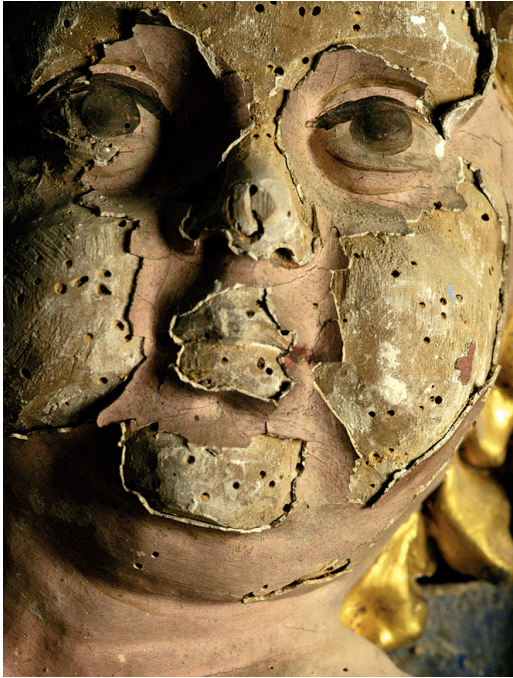
Fig. 92: Detail of the cartouche "God Father"; condition as found

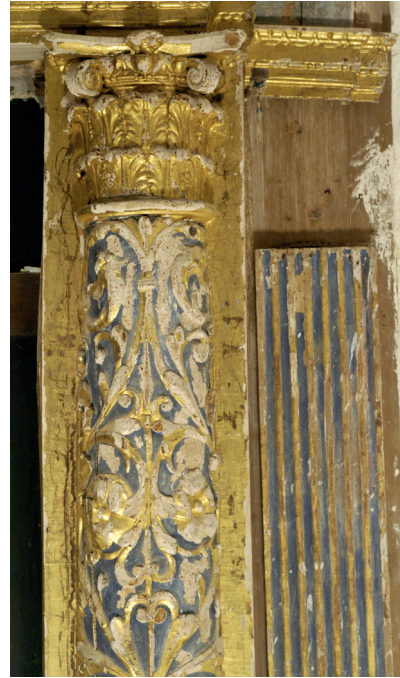
Fig. 93: Right column; condition as found

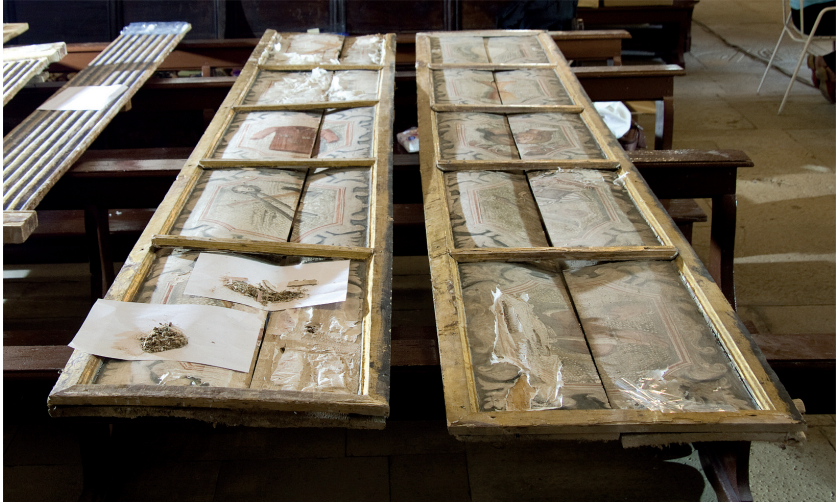
Fig. 94: Demounted panels with the "Arma Christi"; before conservation; detached paint flakes collected for refixing; the extreme warping of the boards is obvious

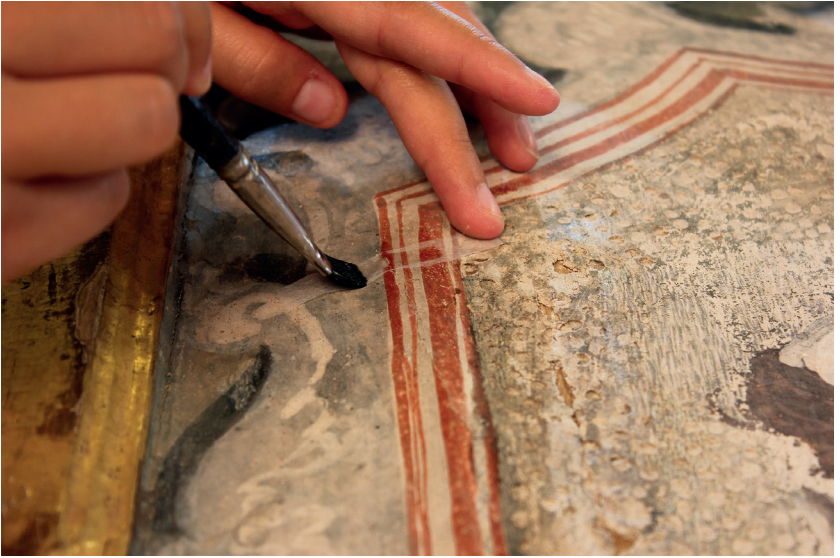
Fig. 95: Applying one strip of the facing

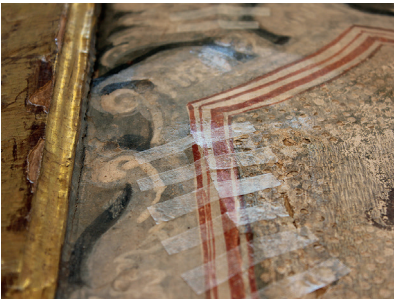
Fig. 96: Strips of Japanese paper over bulged area

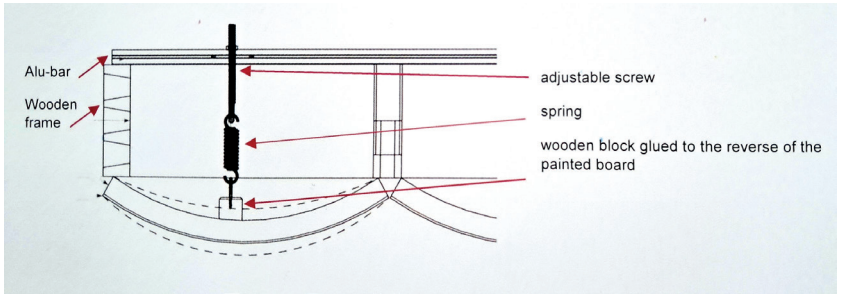
Fig. 97: Scheme of the implemented system

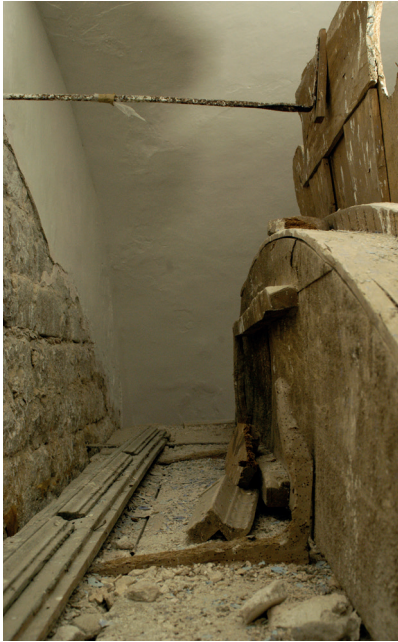
Fig. 101: View of the space behind the pediment and cartouche "God Father; condition as found

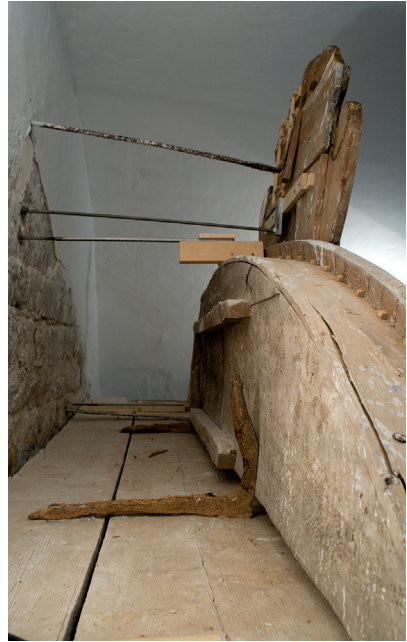
Fig. 102: Condition after treatment; the original mounting with two naturally grown wooden "knees" and one iron strut is reinforced with two additional stainless-steel struts; small wooden blocks stabilise the outer moulding

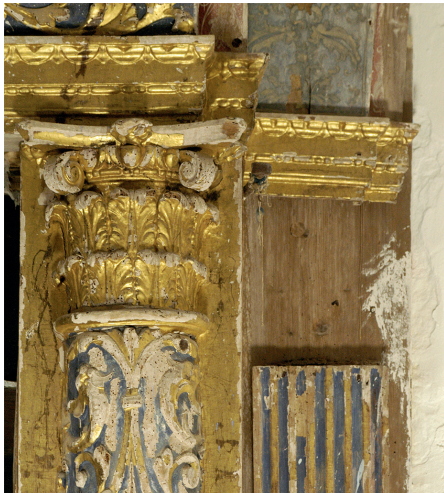
Fig. 104: Upper part of left column and pilaster; condition as found, the capital of the pilaster is missing

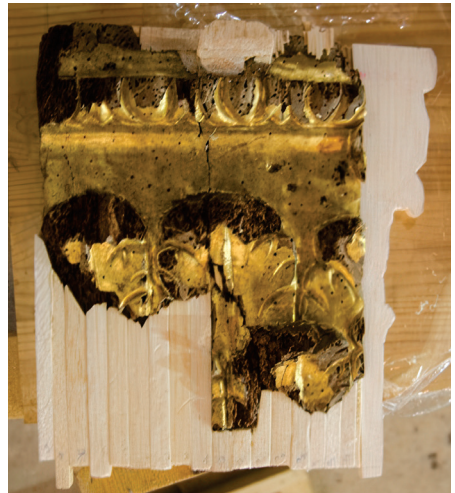
Fig. 105: Recovered fragment of the capital during reconstruction of the volume with balsa wood

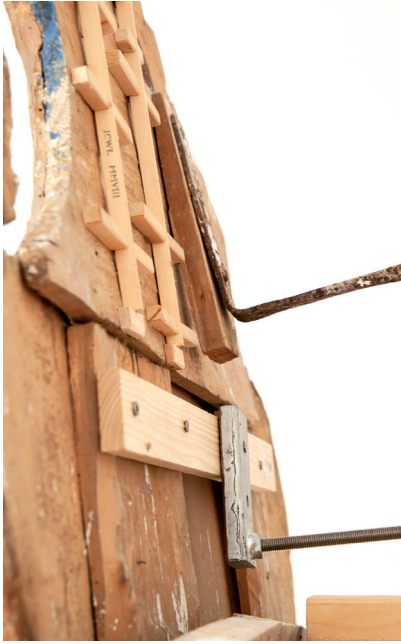
Fig. 103: Condition after treatment; the fragile upper part of the cartouche is stabilised with a movable cradle system

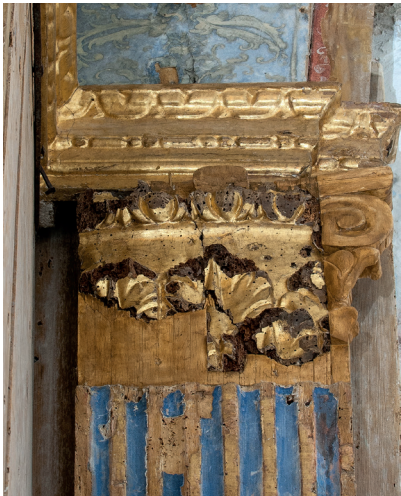
Fig. 106: After reconstruction

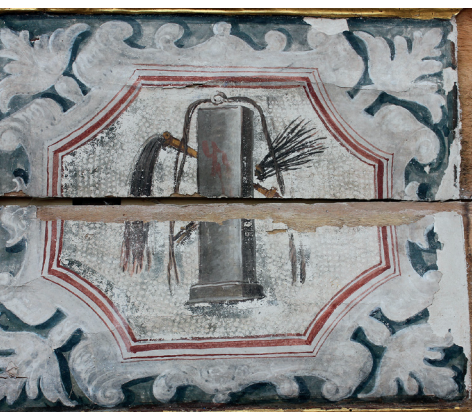
Fig. 107: Before retouching

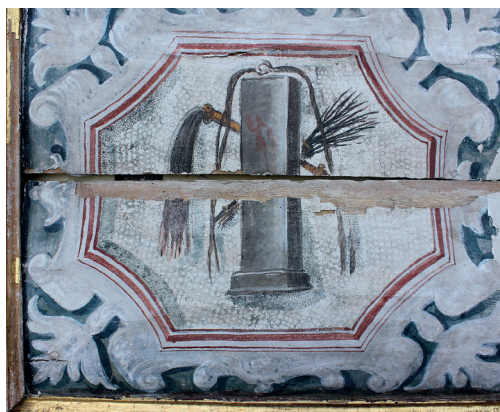
Fig. 108: After retouching

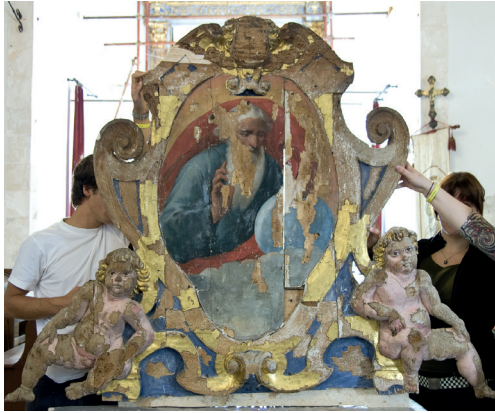
Fig. 109: Cartouche "God Father", after demounting, condition as found

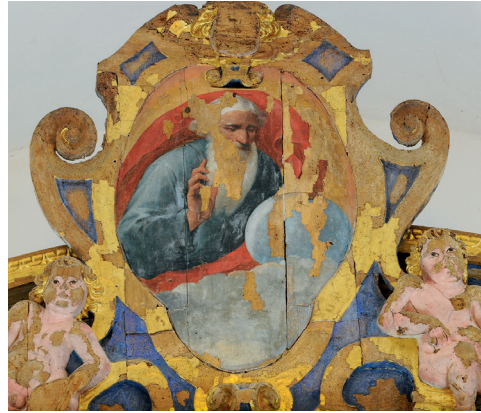
Fig. 110: After treatment

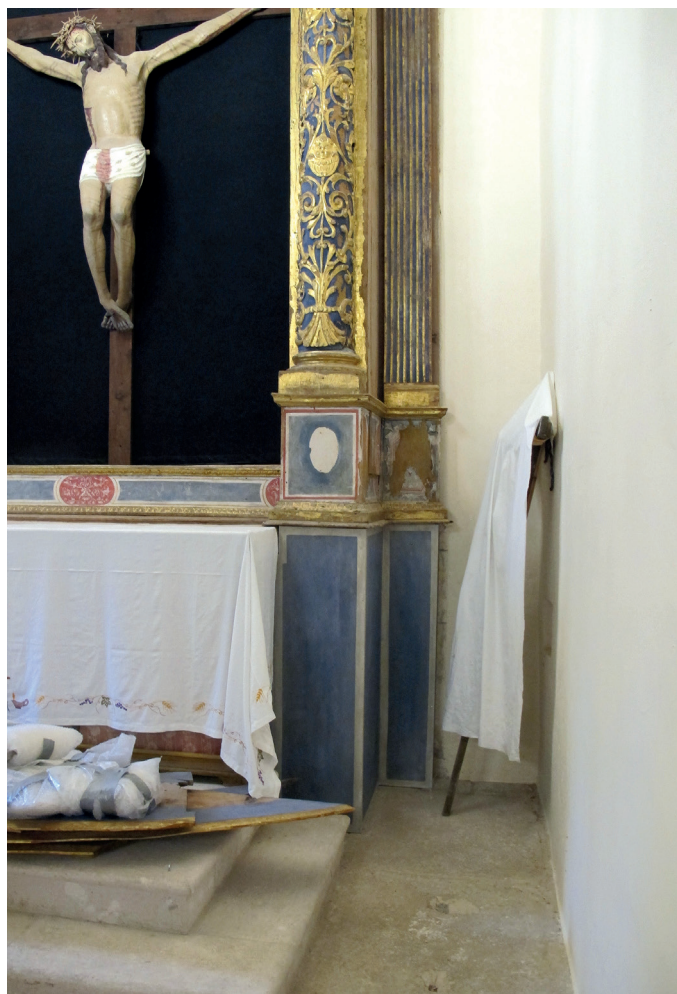
Fig. 111: Holy Cross retable; reconstructed right pedestal
