# Retables on the Croatian Island Lopud

Construction – Polychromy – Restoration

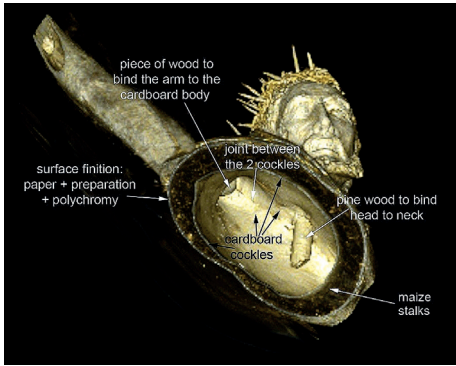
Fig. 112: 3D image processed from the from the CT scan; structure of the sculpture

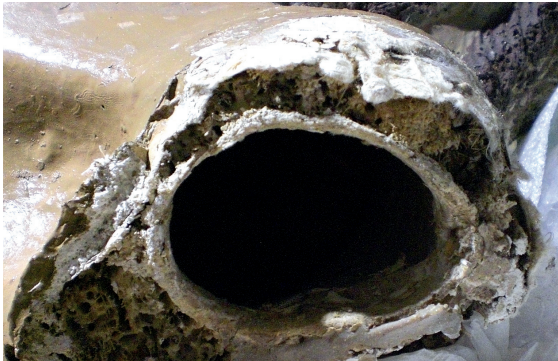
Fig. 119: The shoulder with the paper lined cavity for the arm dowel (condition before treatment)

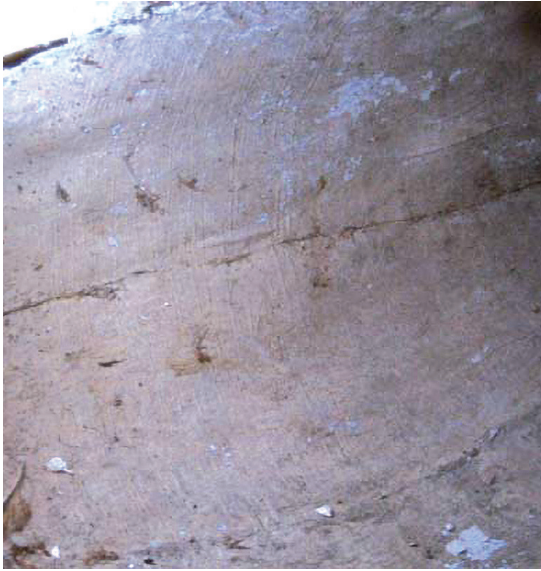
Fig. 120: View through the arm hole; the inner paper shell of the chest

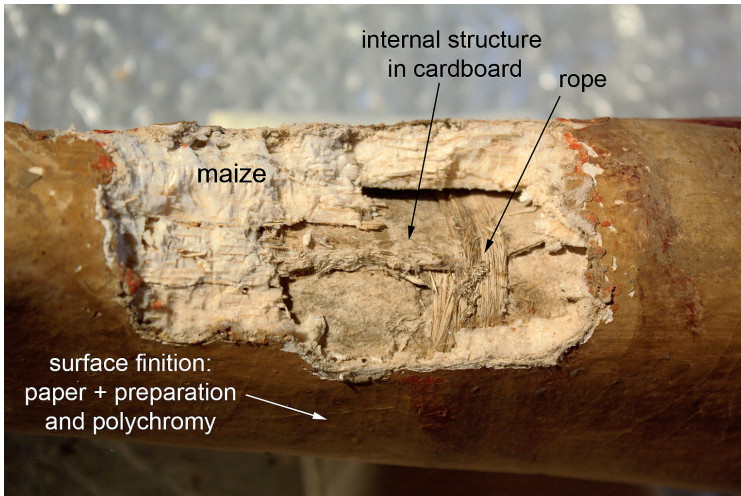
Fig. 122: Insight into a damaged area of the arm; condition before treatment

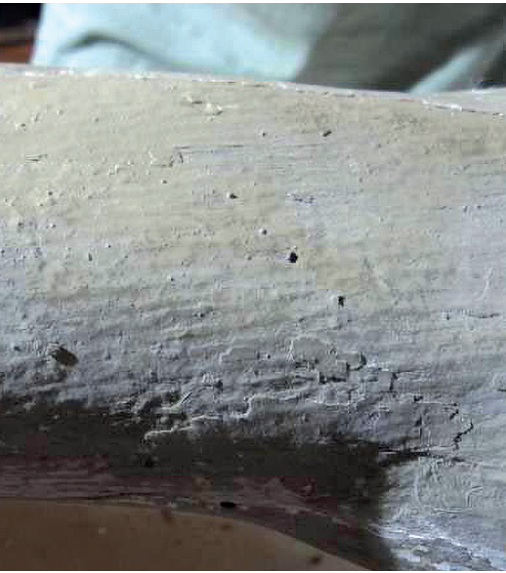
The round pieces of wood at the end of the legs and arms were extended with further pieces of wood to carve hands and feet. The structure of the hands is made of a small board onto which separately cut fingers and the thumb were attached.

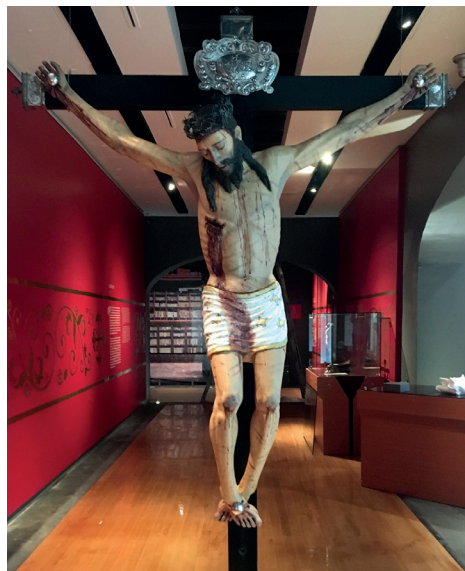
Fig. 125: Crucifix Puebla/Mexico (foto by Pablo F. Amador Marrero in the rooms of Museum Amparo/ Puebla)

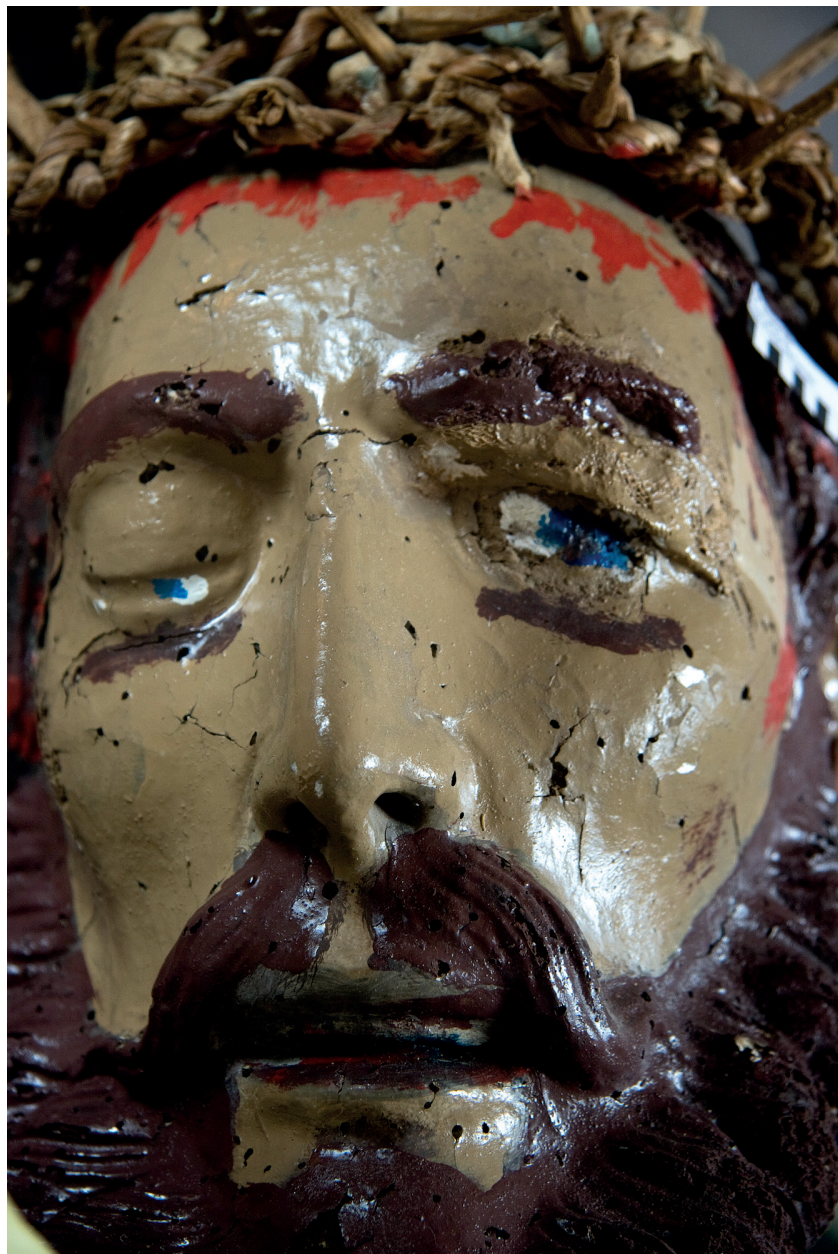
Fig. 127: The overpainted face

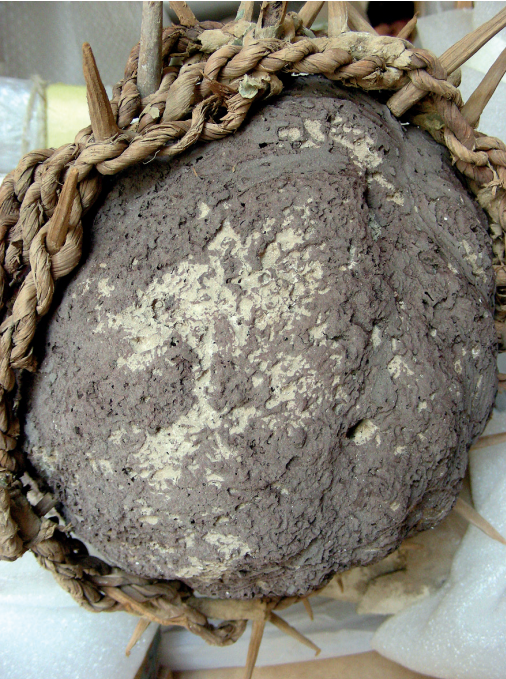
Fig. 128: View of the skull with overpaint over deteriorated surface

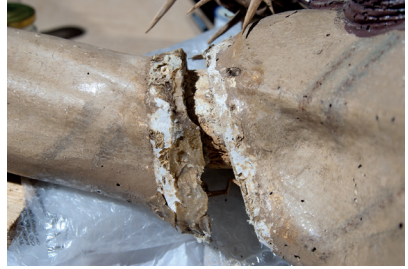
Fig. 129: Detail the arm joint; during removal of overpaint and of superficial repair

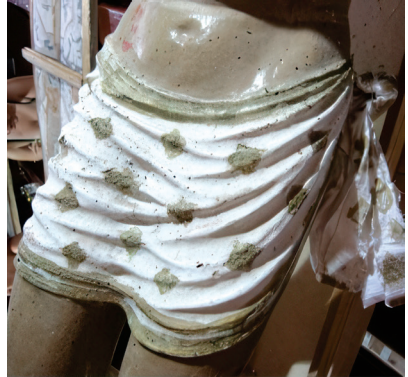
Fig. 130: Overpaint and textile addition to the perizonium

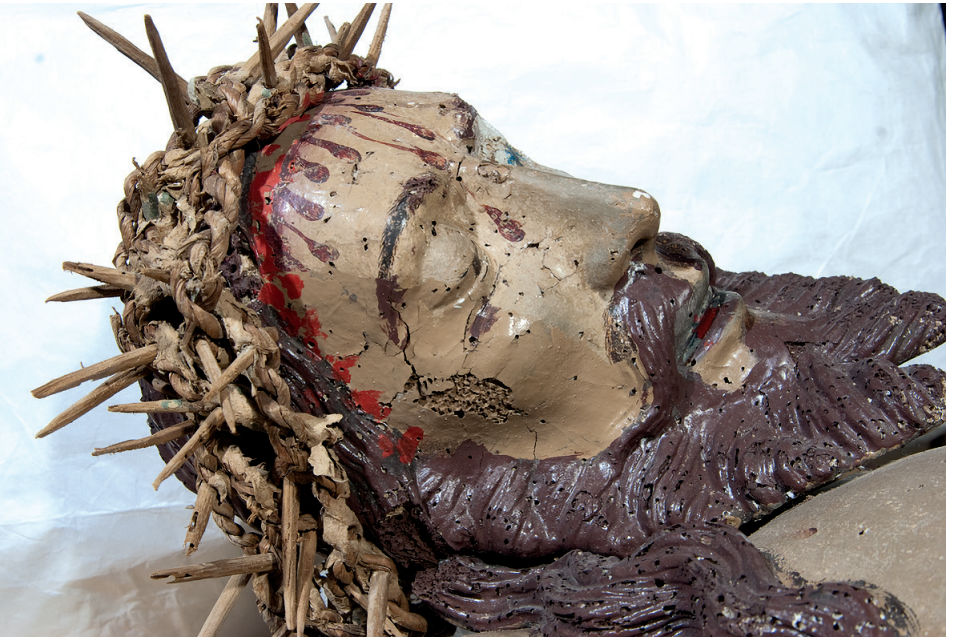
Fig. 131: During removal of overpaint

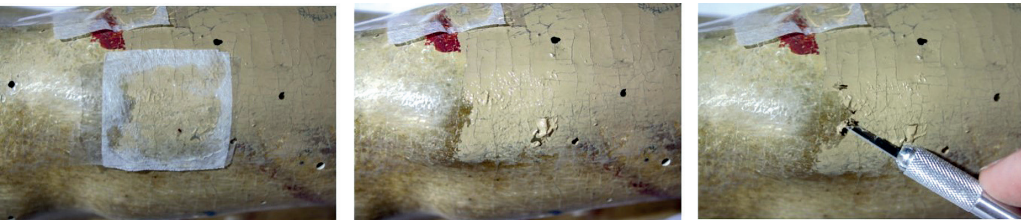
*Consolidation of the flaking preparation and paint layer*

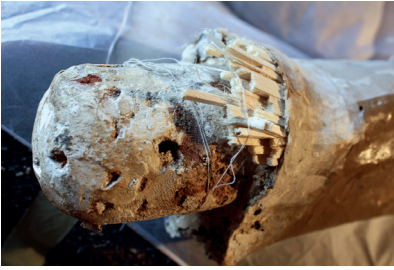
Fig. 133: The arm joint "dowel" during application of *ferula* sticks to increase stability

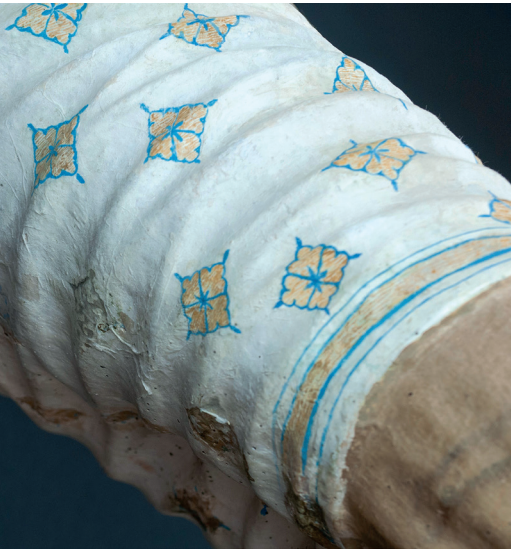
Fig. 136: Side view of the perizonium; reconstruction of the pattern on top of an intermediate Japanese paper

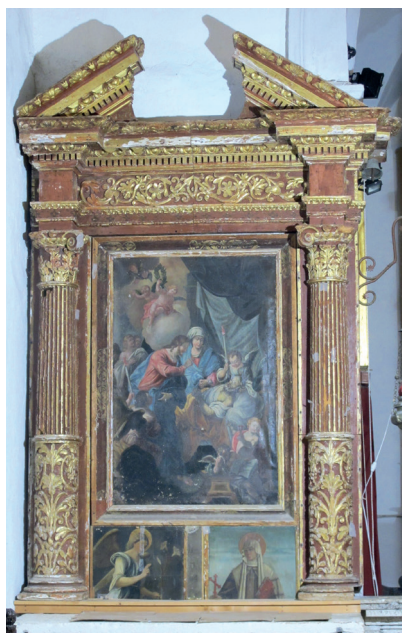
Fig. 145: St Joseph retable; (as found, 2011)

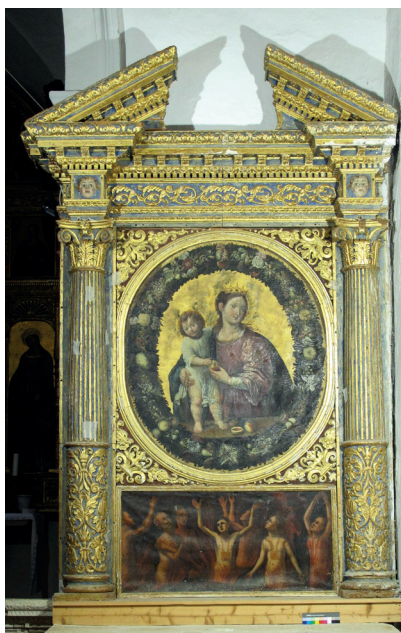
Fig. 146: St Mary retable (Holy Mary of Carmel); (as found, 2011)

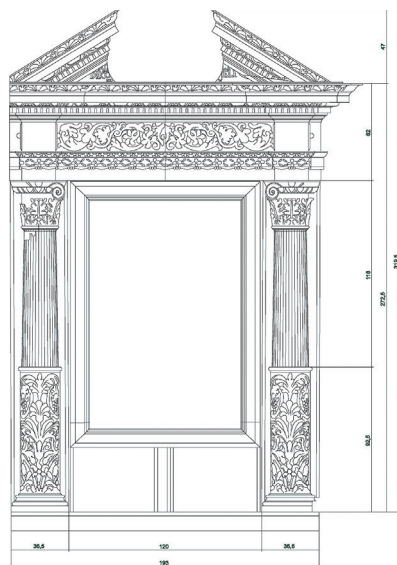
OBJECT	DATE OF STUDY	PHASE	DOCUMENTATION	AUTHOR	PETER-PERLAN
RETABLE OF ST. JOSEPH (RETABLE FOUND FROM THE PARISH CHURCH OF OUR LADY OF ŠPILICE)	2011	SKICA	1/10	2011	2011

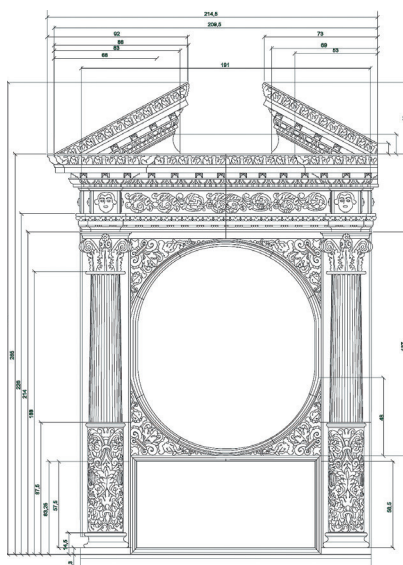
OBJECT	DATE OF STUDY	PHASE	DOCUMENTATION	AUTHOR	PETER-PERLAN
RETABLE OF HOLY MARY OF CARMEL (RETABLE FOUND FROM THE PARISH CHURCH OF OUR LADY OF ŠPILICE)	2011	SKICA	1/10	2011	2011

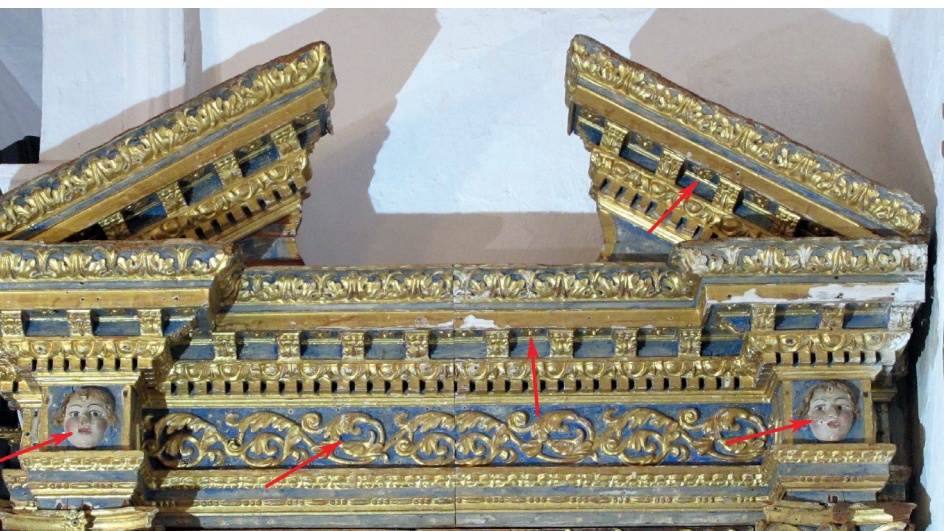
Fig. 149: St Mary retable; entablatura and gable; red arrows indicate the cartapesta elements

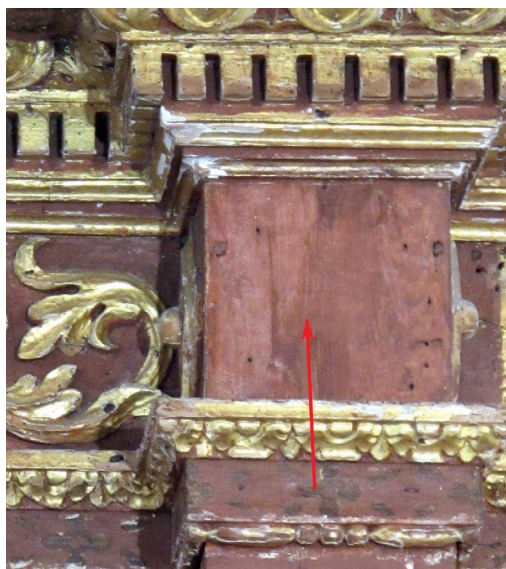
Fig. 151: St Joseph retable; (condition as found); the rectangular protruding elements of the entablatura were originally decorated with an applied decoration. A “pattern” of nails, nail holes, cutting traces and fragments of fibrous material underneath some nail heads indicate the deliberate removal of some decorative element. It is most likely that the lost decoration was similar to those on the retable of Holy Mary, showing heads of putti, made in cartapesta. The brown color on this area is probably a later local touch-up

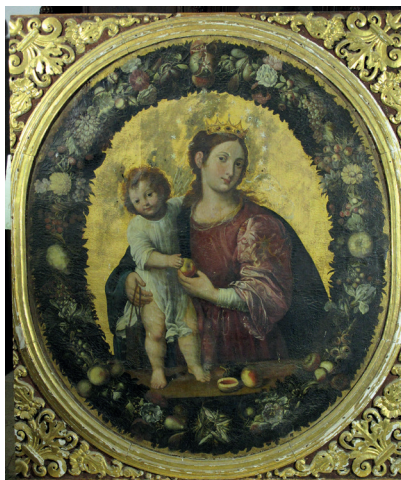
Fig. 152: Our Lady of Carmel, as found 2011 (not part of the ICWL project)

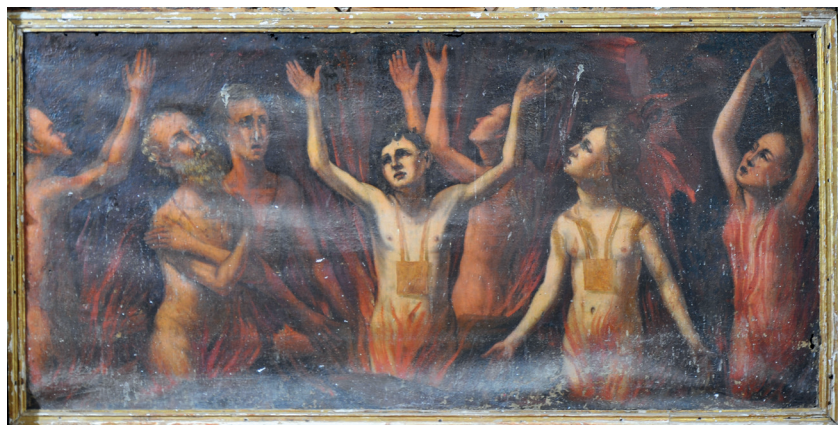
Fig. 153: Purgatory painting before treatment (as found 2011)

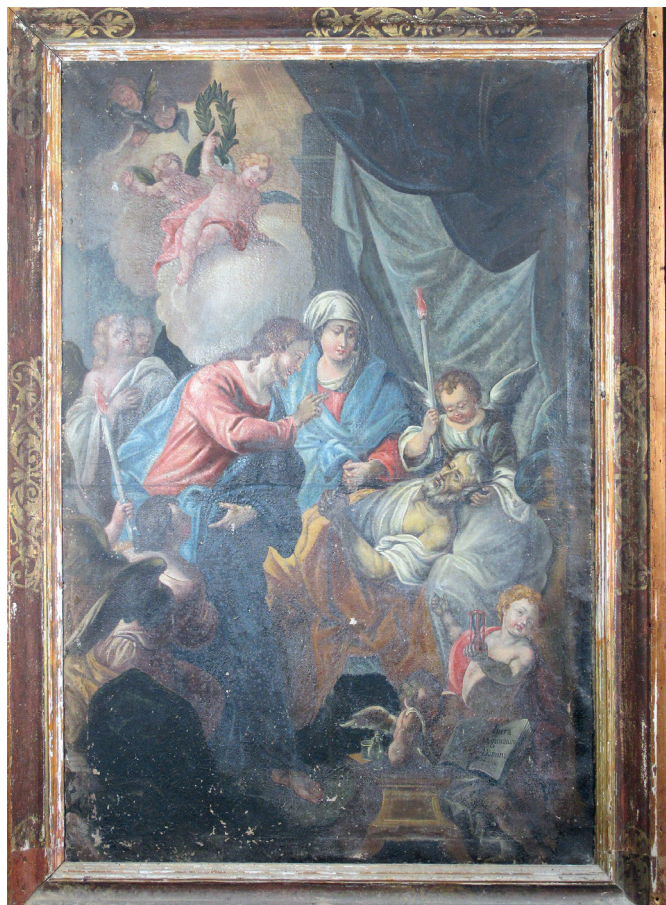
Fig. 154: Death of St Joseph (as found 2011)

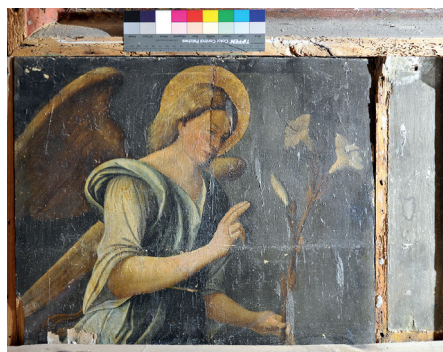
Fig. 155: Archangel Gabriel (as found 2011, not treated within the ICWL)

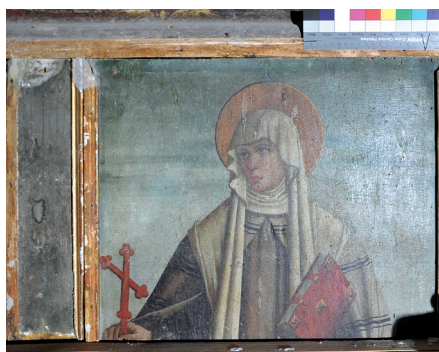
Fig. 156: St Clara (as found 2011, not treated within the ICWL)

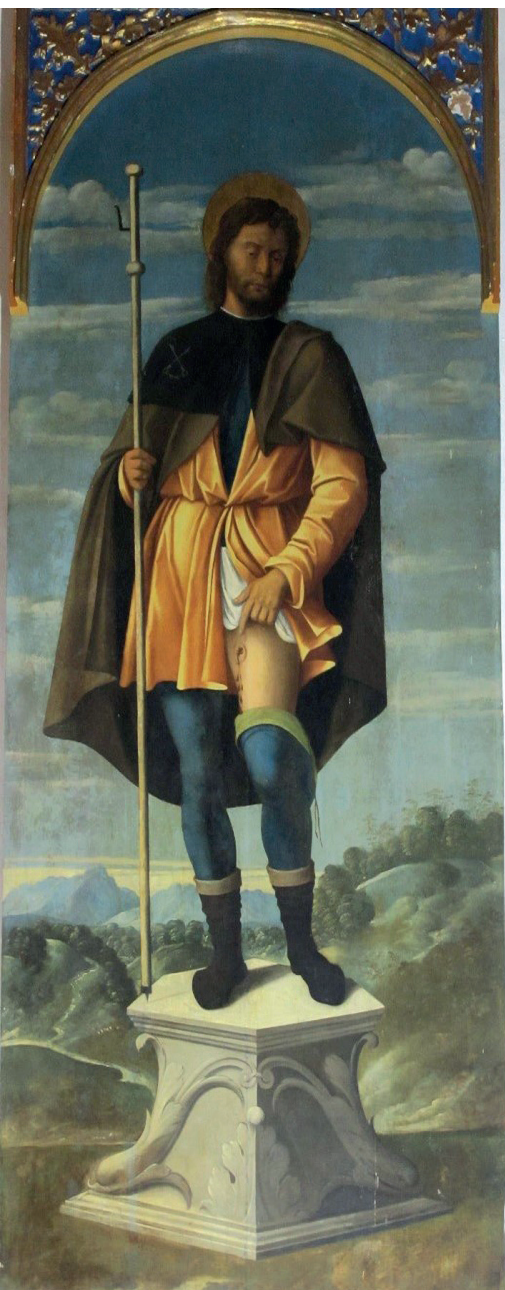
Fig. 157: St Roch (by Girolamo di Santa Croce), (not treated within the ICWL)

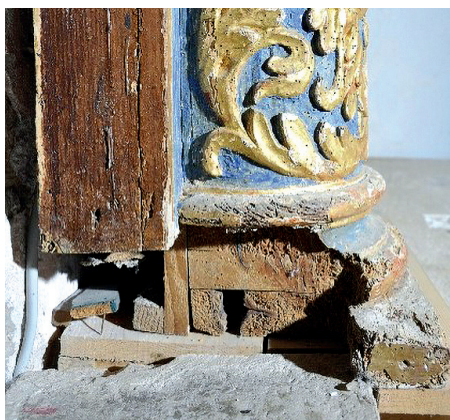
Fig. 161: Mary retable (condition as found); base of the left column; visible cut-out. The cut-out was made to insert the retable between the cover plate of the septum and the wall. After the later lifting of the retable onto the modern box-like subconstruction, this cut-out was left untreated

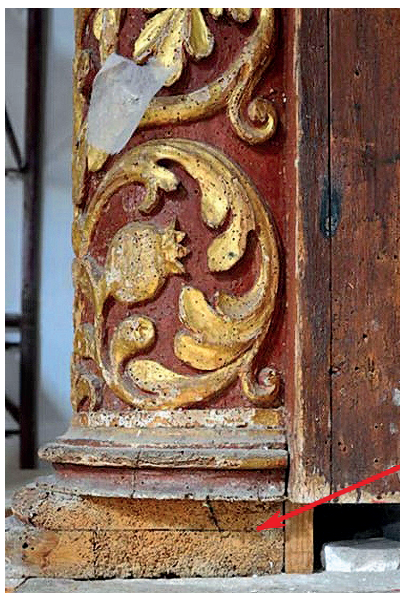
Fig. 162: Joseph retable; here the same cut was made in the base of the right column. It is most likely that this cut was made to obtain a position directly on the surface of the mensa. The cut was made for the railing of the septum which is about 10 cm higher than the mensa. Later, the modern under-construction was made to lift the position of the retable onto the niveau of the septum again. No attempt was made to close the large, then visible gap

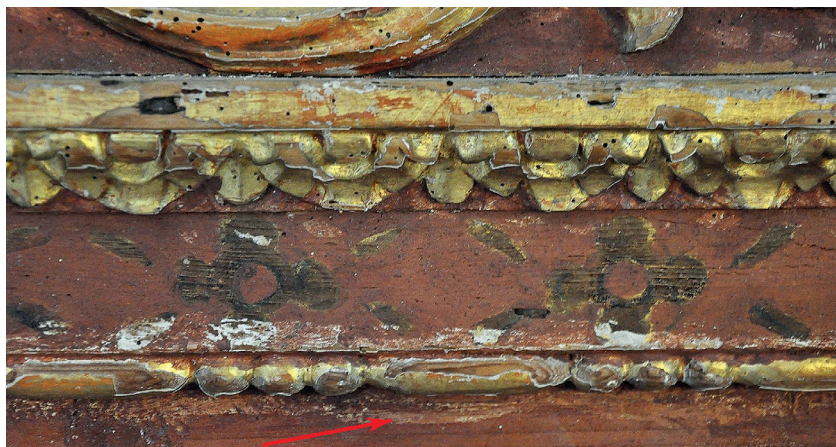
Fig. 163: St Joseph retable; architrave, detail with brownish quatrefoil ornament; note the simple quality and poor hiding power of the general brown colour, the preparation for only the gilded elements is clearly visible (red arrow); condition before treatment, 2011

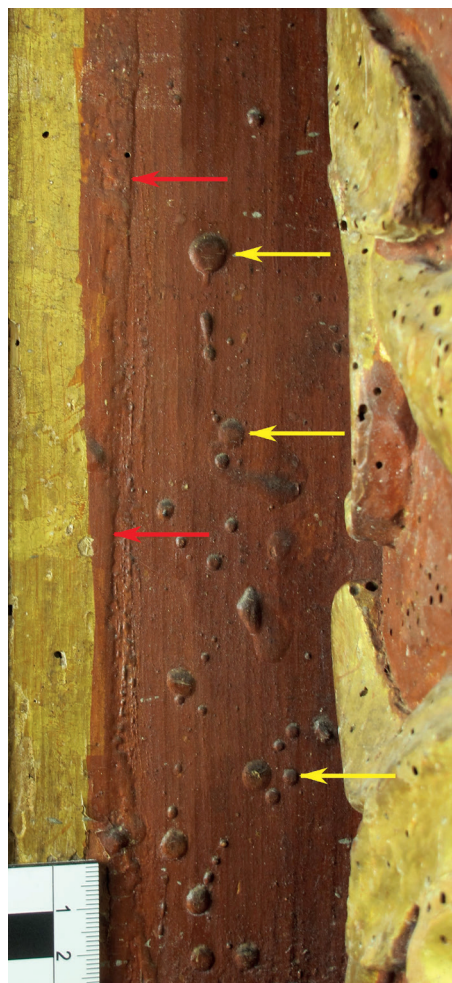
Fig. 164: St Joseph retable, detail next to the right column, raking light; Preparation was only applied for the golden contour (red arrows) and the carved ornaments of the columns; drops and superficial material (yellow arrows) from the careless execution are visible everywhere and were not smoothed out before the imprecise application of the brown paint.

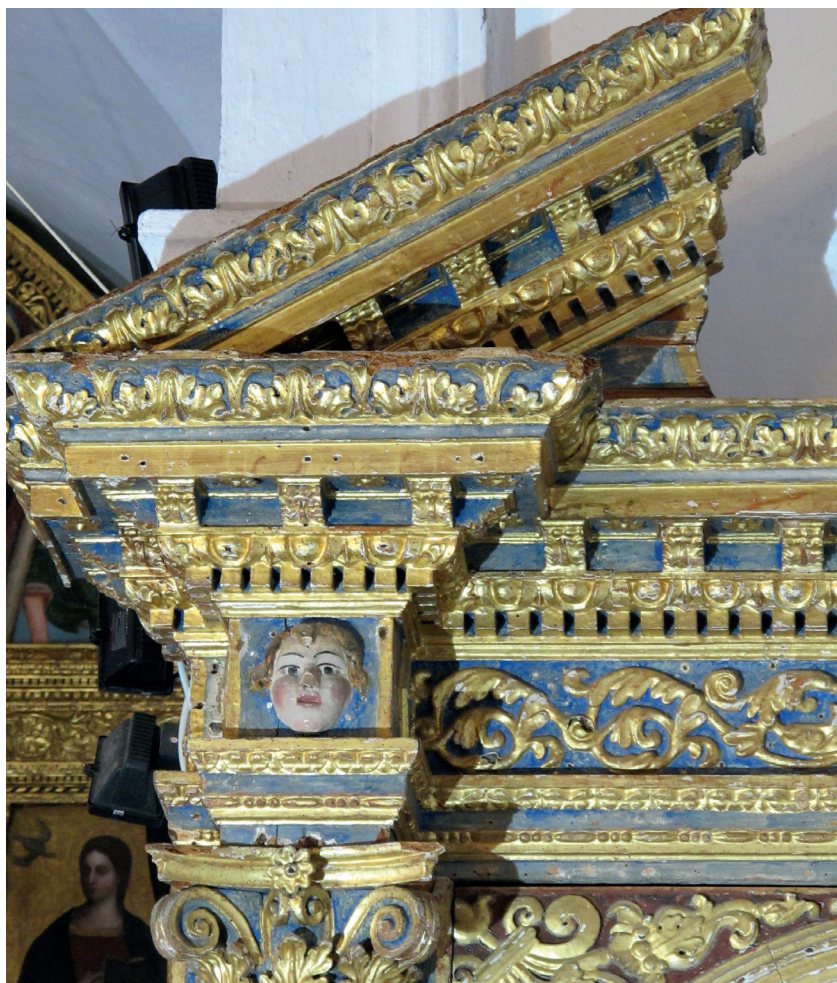
Fig. 165: St Mary retable, condition as found; the variation in the appearance of the blue paint is clearly visible

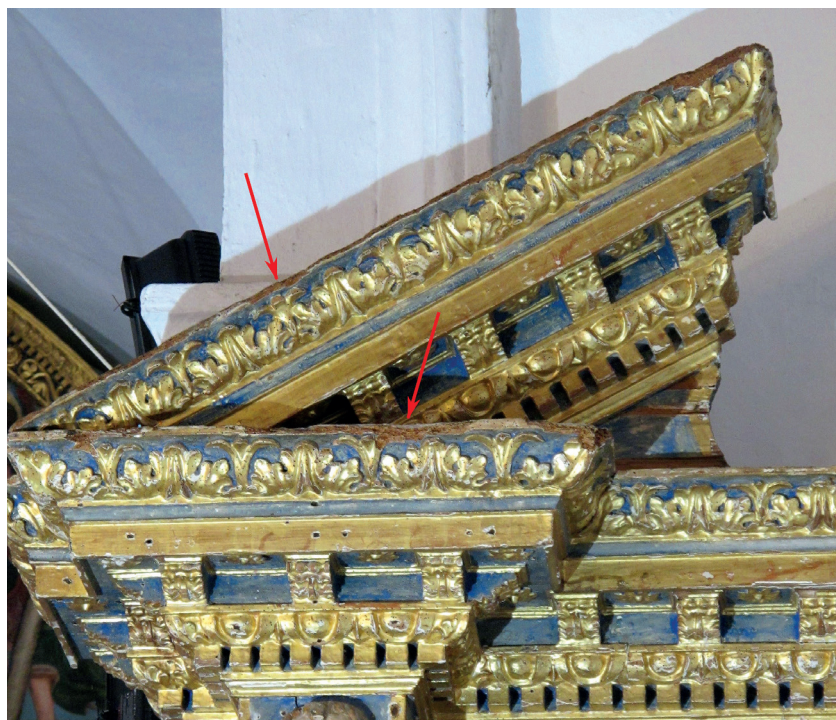
Fig. 166: St Mary retable; condition as found; losses in the outer contour

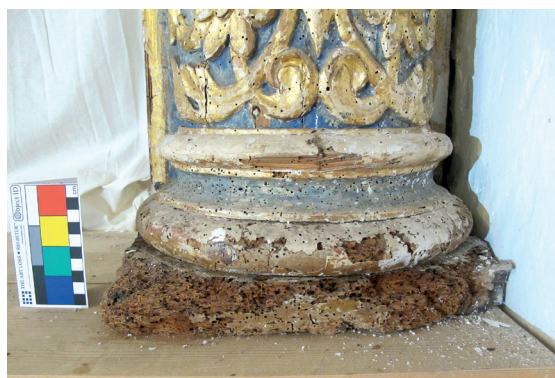
Fig. 167: St Mary retable, plinth of the right column, condition as found; deterioration of wood

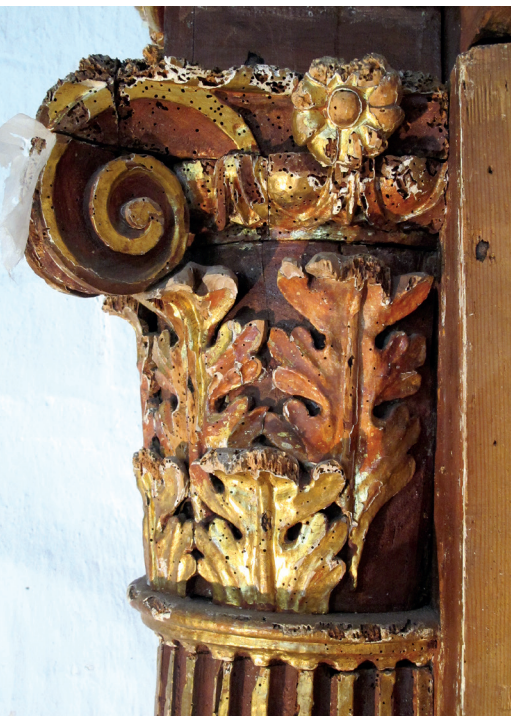
Fig. 168: St Joseph retable, condition as found; losses of thin carved softwood areas

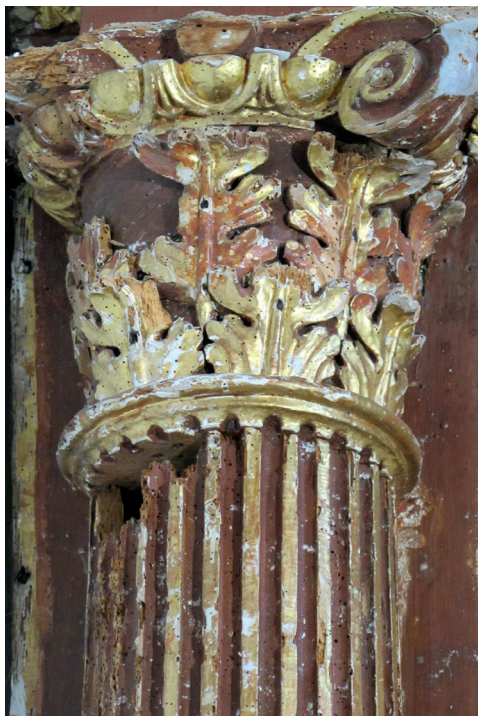
Fig. 169: St Joseph retable, condition as found; losses of leaves in the capital and the upper part of the fluted column

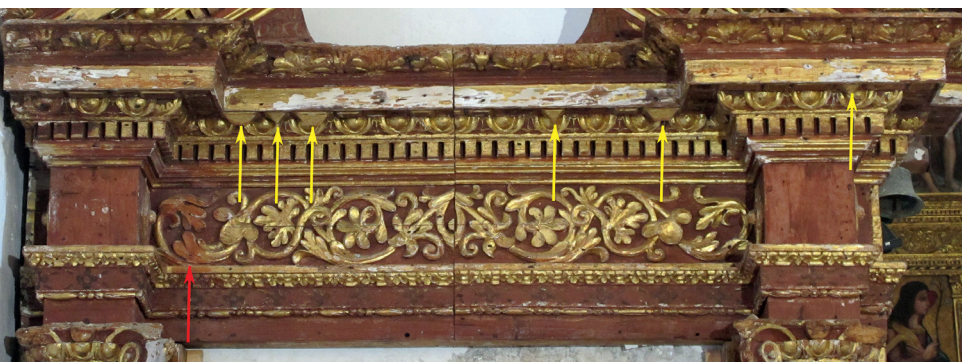
Fig. 170: St Joseph retable, condition as found; clearly visible losses in gilding, the upper contour of the entablature is destroyed by insects. Many of the separately carved diamond-shaped applications are lost. Yellow arrows indicate the few surviving ones. The red arrow indicates the area where the gilding shows a reddish discoloration.

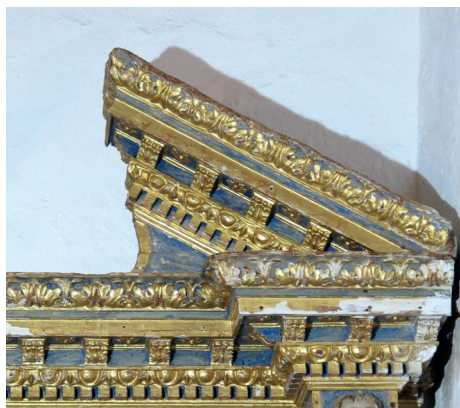
Fig. 171: St Mary retable; layer separation in the preparation has caused losses in the gilding

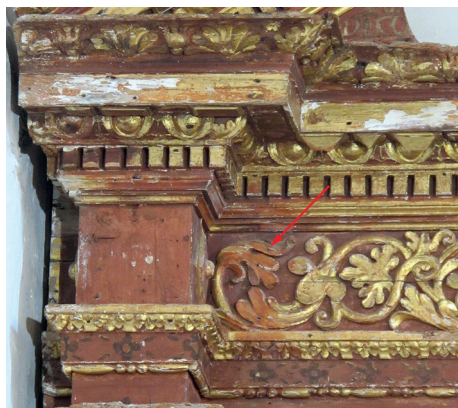
Fig. 172: St Joseph retable; reddish appearance of gilding

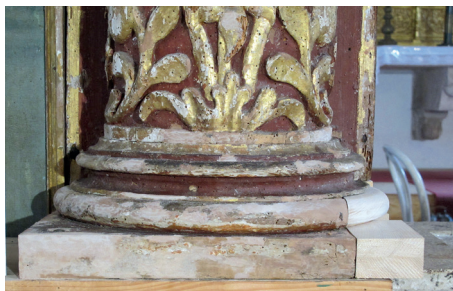
Fig. 173: During formal reconstruction with massive wood

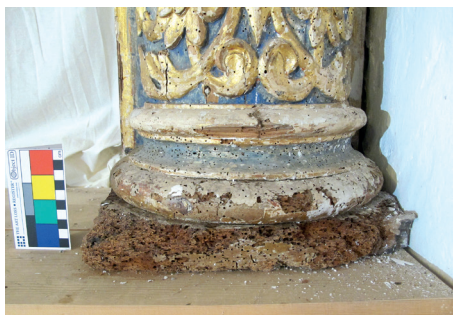
Fig. 177: St Mary retable, right column; condition as found

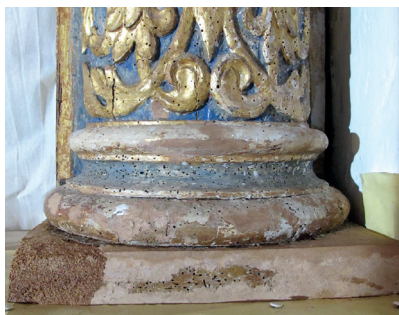
Fig. 178: During reconstruction with filler formulations

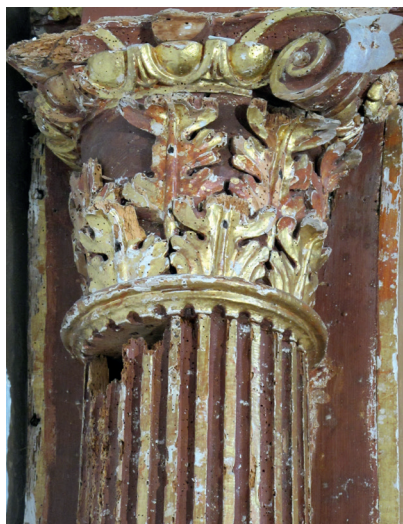
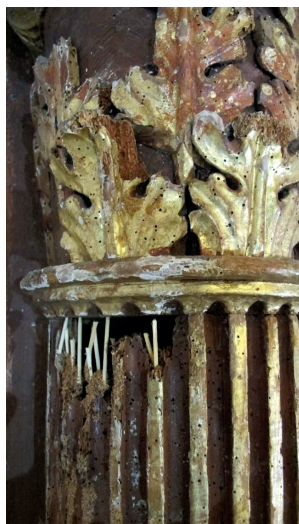
Fig. 181: First reinforcement with bamboo sticks

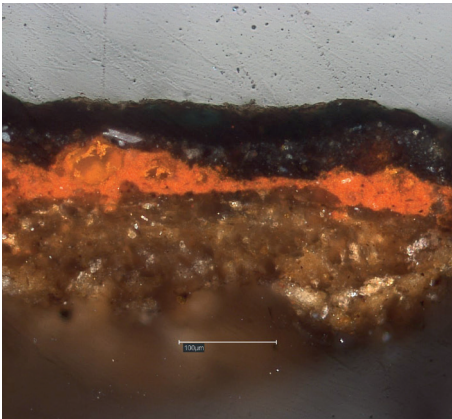
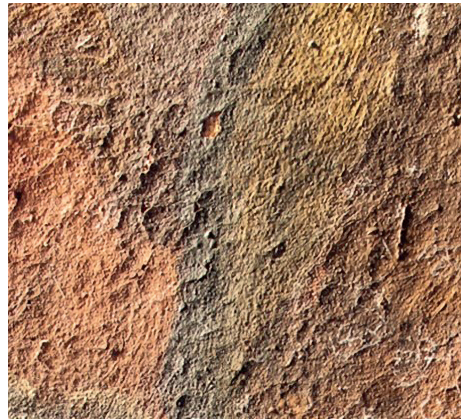
Fig. 191: Cross-section (Sample PS1), with a brown and a red preparation layer (taken from the greenish drapery in the bottom left area of the painting), VIS, the scalebar is 100µm

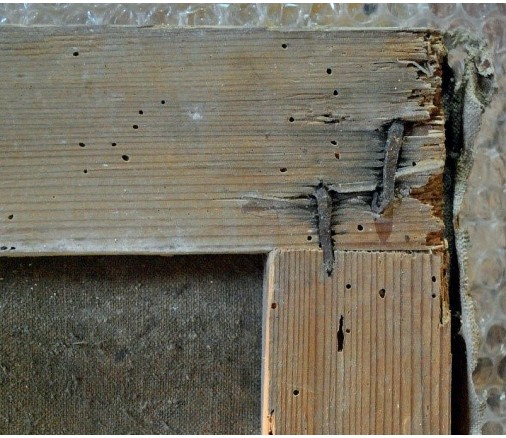
Fig. 193: Reworked corner joint

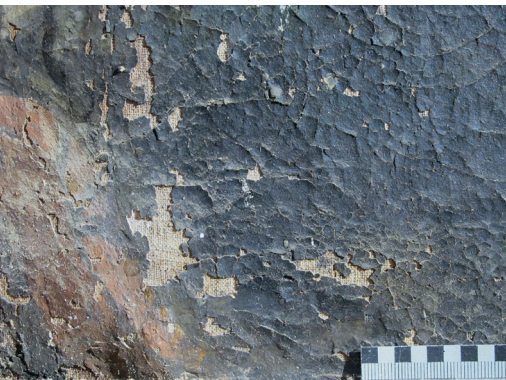
Fig.194: Condition of the paint layer (left lower corner)

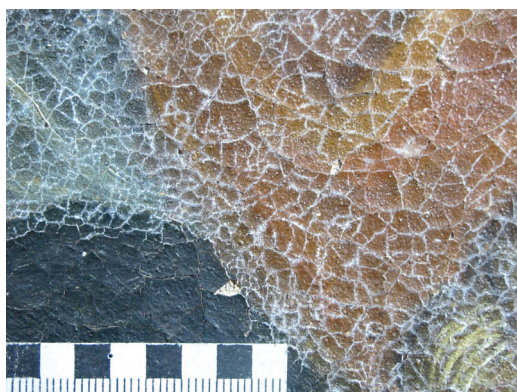
Fig. 196: Crystallised salt along the craquelure

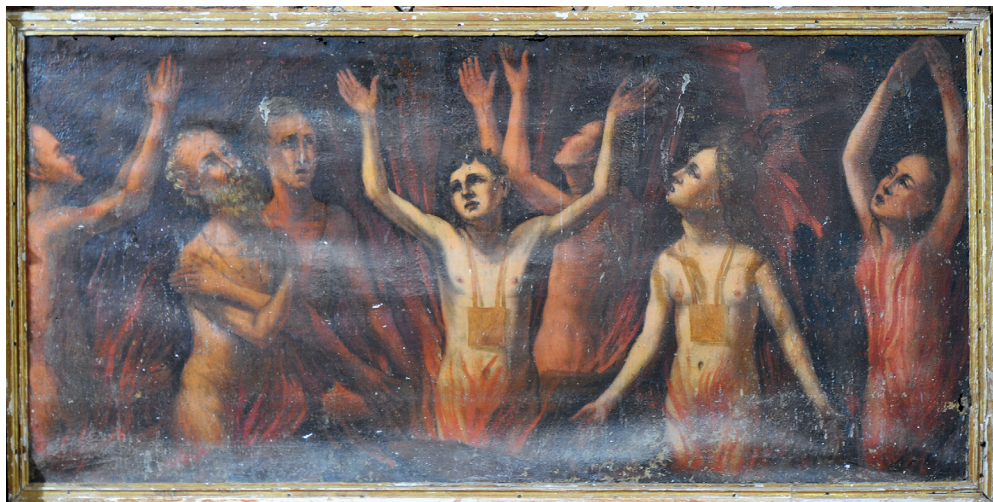
Fig. 203: Mary retable; canvas painting "Purgatory"; condition before treatment

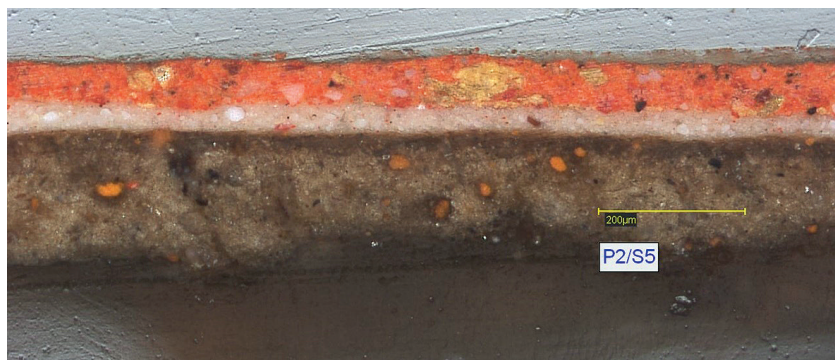
Fig. 205: Cross-section (sample No P2/S5); The greyish preparation has a darker upper border, which could be an isolation layer. A thin layer of incarnate and the red layer for the flames follow (the measurement bar is 200 µm)

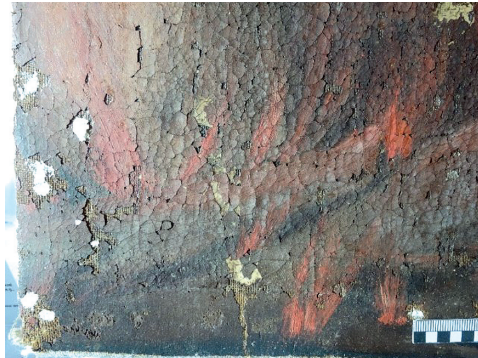
Fig. 207: Condition after the dirt and varnish removal: matte and leached paint surface (nail holes already closed with pulp filler)

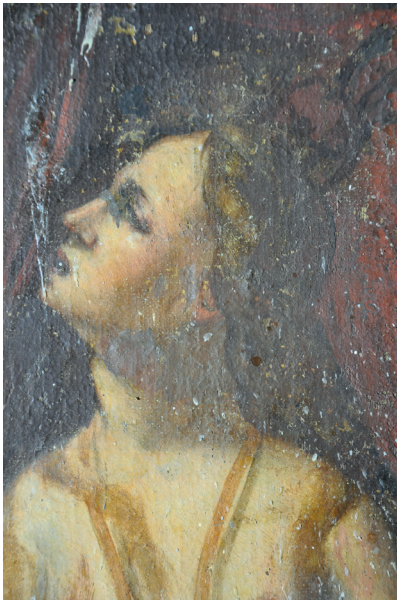
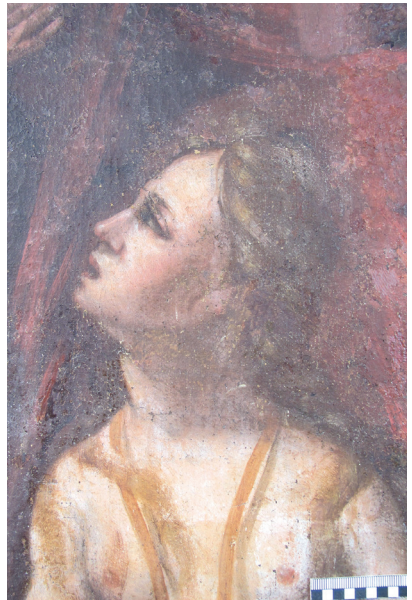
Fig. 208: "Purgatory"; condition as found: dirt, wax and disturbing overpaint; after removal of overpaint and during retouching

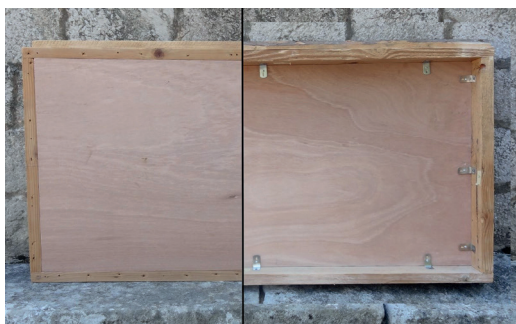
Fig. 215: Strainer box with backboard protection; front (left) and back (right)

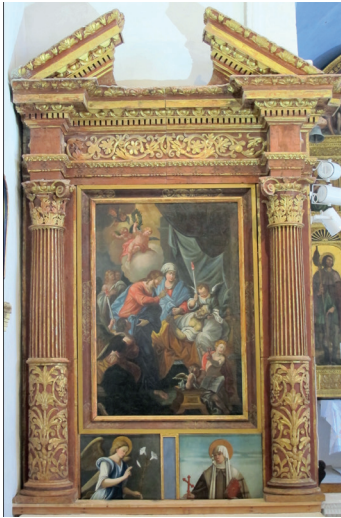
Fig. 223: Lopud, Gospa Maria Špilica; Joseph retable

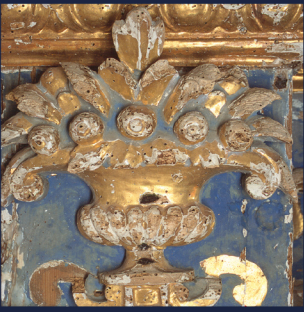
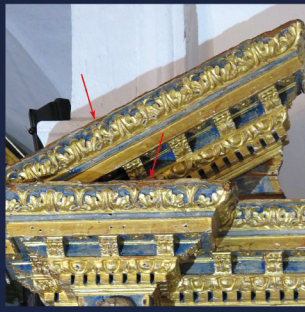
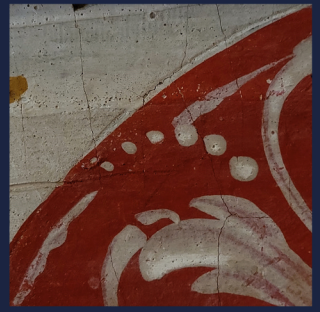
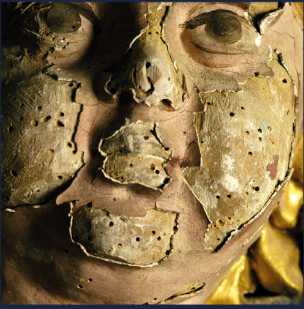
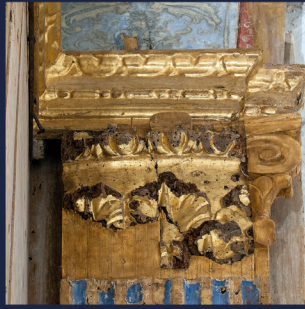
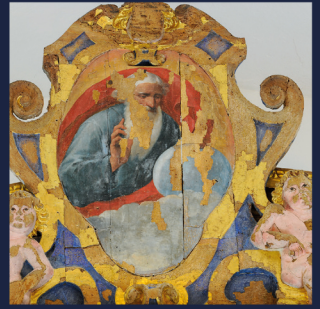
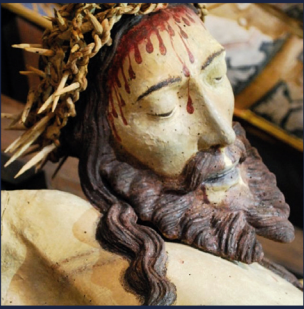
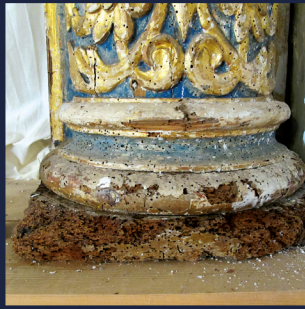
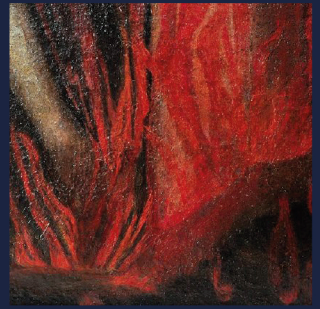
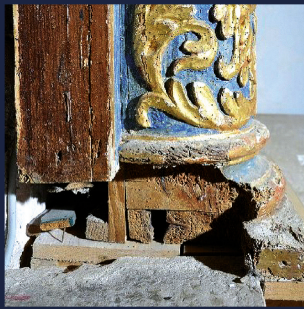
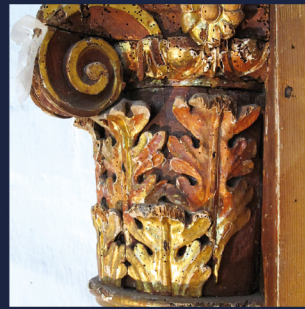
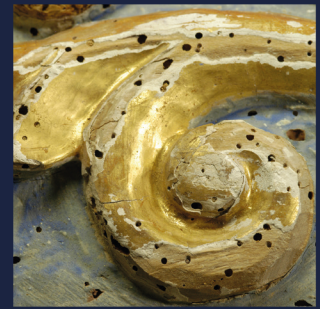
Thieme, Isabella; Hess, Martin, Risszusammenführung und Festigung großflächiger Malschichtstauchungen an einem Leinwandgemälde. In: Zeitschrift für Kunsttechnologie und Konservierung, 13/1999, Vol. 1, p. 55 - 62.
