Innovative Plasma Sprayed Thermal Barrier Coatings for Enhanced Flexibility in Gas Turbine Operation

Jens Igel

Forschungszentrum Jülich GmbH
Institute of Energy Materials and Devices (IMD)
Werkstoffsynthese und Herstellungsverfahren (IMD-2)

D 294 (Diss. Bochum, Univ., 2025)

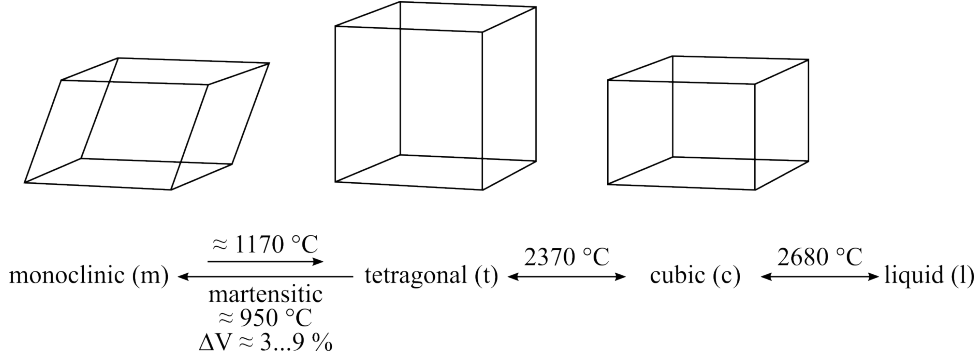
Fig. 2.7 Phase changes in ZrO_2 adapted from [33] and [99]

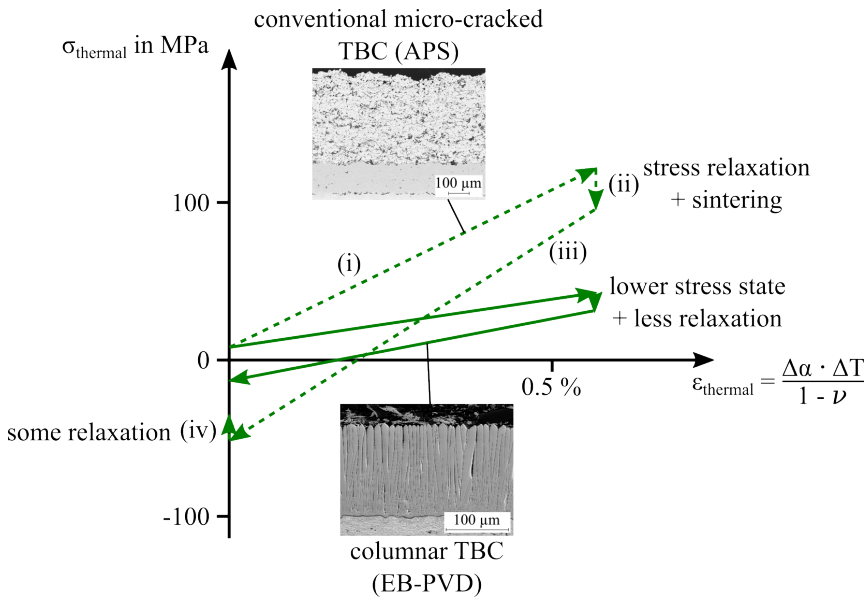
Fig. 2.9 Qualitative stress development within APS (dotted line) and EB-PVD (solid line) TBCs deposited on a nickel-based superalloys during heating (i), dwell time at temperature (ii), cooling (iii) and at room temperature (iv) according to [115]

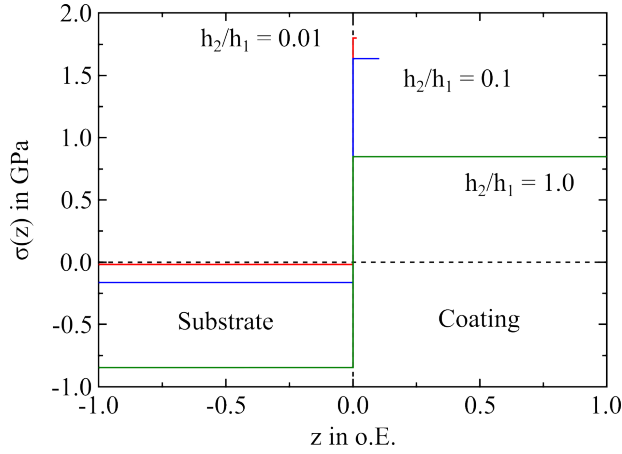
Fig. 2.11 Stress level in a ZrO_2 coating on nickel-based superalloy after heating to 1000 K; h_2/h_1 is the coating/substrate thickness ratio [130]

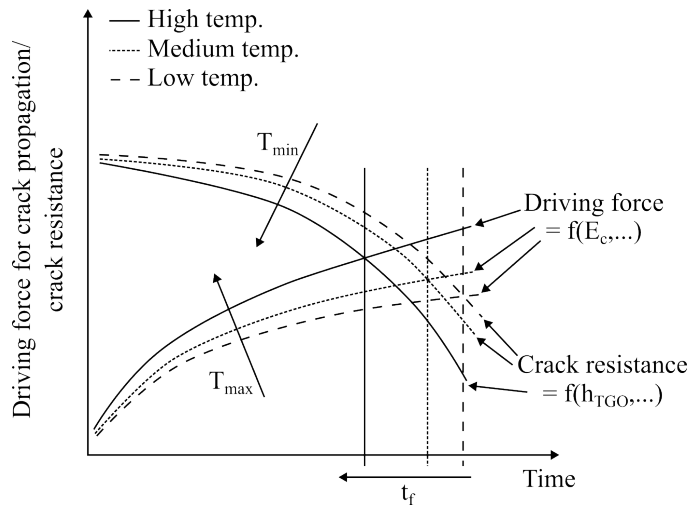
Fig. 2.14 Temperature- and time-dependent curves of the driving force for crack propagation and the crack resistance in the interface area of a thermal barrier coating system according to [144]

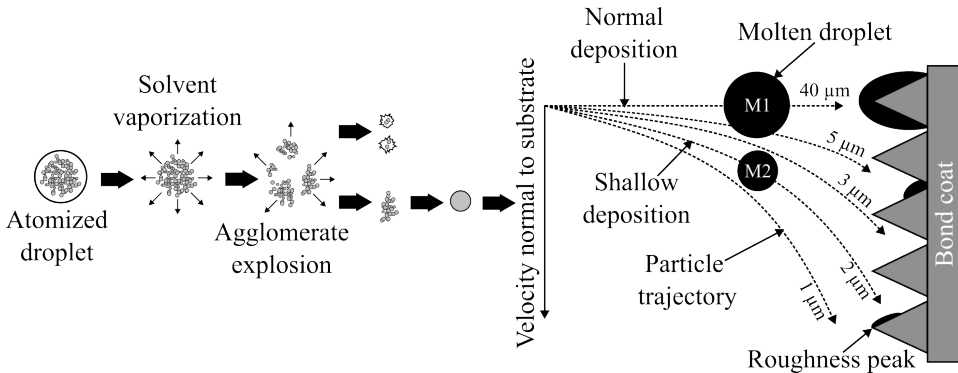
Fig. 2.22 Schematic illustration of the plasma-particle interaction during suspension plasma spraying [175] and the droplet trajectories and their impact on the bond coat asperities [176]

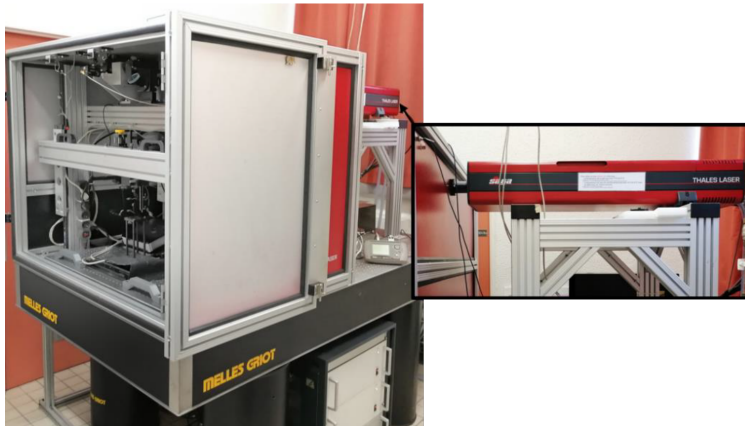
Fig. 4.5 LASAT device of the Center des Matériaux [199]

The LASAT investigations were performed at Centre des Matériaux at Mines ParisTech (Paris, France) using the facility shown in Figure 4.5. A SAGA model Nd:YAG laser source (Thales, Paris, France) is installed in this system. The laser operates within the green spectrum, emitting light at a wavelength of 532 nm. The amount of energy acting on the sample can be adjusted between 0.1 and 2 J with a polarization device. The transmitted energy of the laser beam is monitored by a joule meter. The laser source generates pulses with a half-life of 5.2 ns at a frequency of 10 Hz. In the investigations presented in this thesis, the laser was operated in single pulse mode, so that a single pulse of 5.2 ns duration is applied to the samples.

An additional confining medium can be used at the focal point of the laser. For this purpose, water, glass or a transparent adhesive tape can be applied, of which the adhesive tape with a thickness of 50 μm (3M) was chosen in this work. The confining medium limits the plasma expansion, allowing to generate higher and longer pressure loads with the same laser parameters (power density peak, pulse duration, wavelength) than without a confining medium [207]. Furthermore, two different shock modes can be employed. On the one hand, the shocks can be applied to the metallic substrate side and on the other hand to the ceramic top layer. This changes the shock wave path through the material and is mainly used when it is not possible to apply a shock to the substrate side. This is the case, for example, when coatings are tested on turbine blades. To protect the ceramic, a black adhesive tape, which acts as an ablative medium, is then applied under the transparent adhesive tape, which is used as the confining medium. An approximately 200 μm thick black PVC adhesive tape (3M) was used for this purpose. This could be evaporated by the laser pulse without damaging the underlying coating.
