## **Vertiefte Untersuchungen zum hochenergetischen Versagen elektrischer Komponenten (HEAF) mit möglicher Brandfolge**

Marina Röwekamp

November 2015

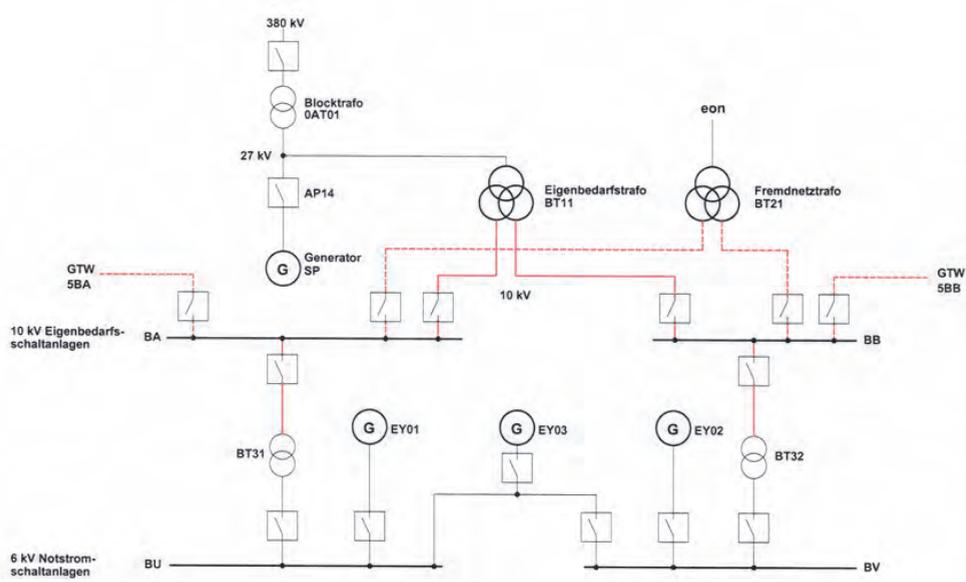
Fig. 1. Scheme of the electric circuit affected

This event, which occurred in a 10 kV cable at a BWR type plant, has been analyzed in detail by the responsible expert organization on behalf of the regulator in charge (Berg & Katzer et al., 2009). Details on the electric circuit are provided in Figure 1.

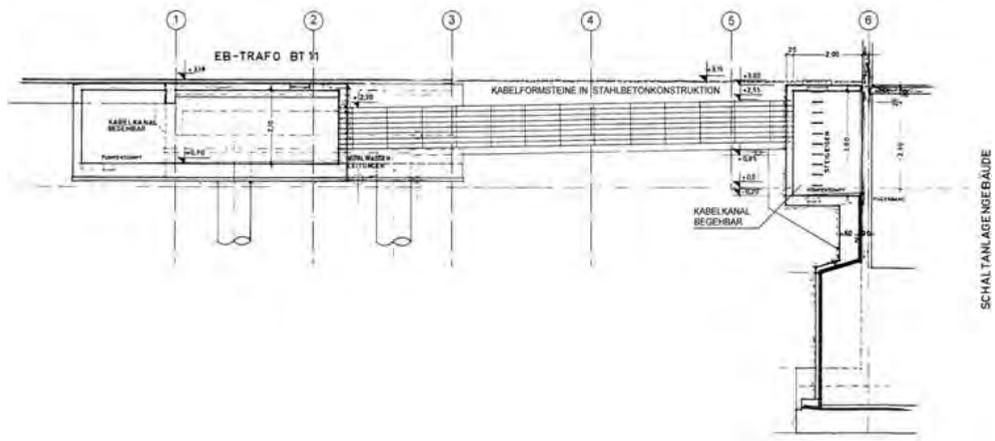
Fig. 2. Cross section of the cable tray inside the cable cylinder blocks inside ground between the buildings

Due to the conditions in the ground, cables were partly imbedded in so-called 'cable cylinder blocks' manufactured from concrete (see Figure 2).

The detailed analysis led to the definite result that the event was mainly caused by ageing of the 10 kV cables. The ageing process was accelerated by the insufficient heat release inside the cable cylinder blocks.

As a corrective action, all high voltage (mainly 10 kV) cables with PVC shielding being older than 30 years were replaced by new ones.

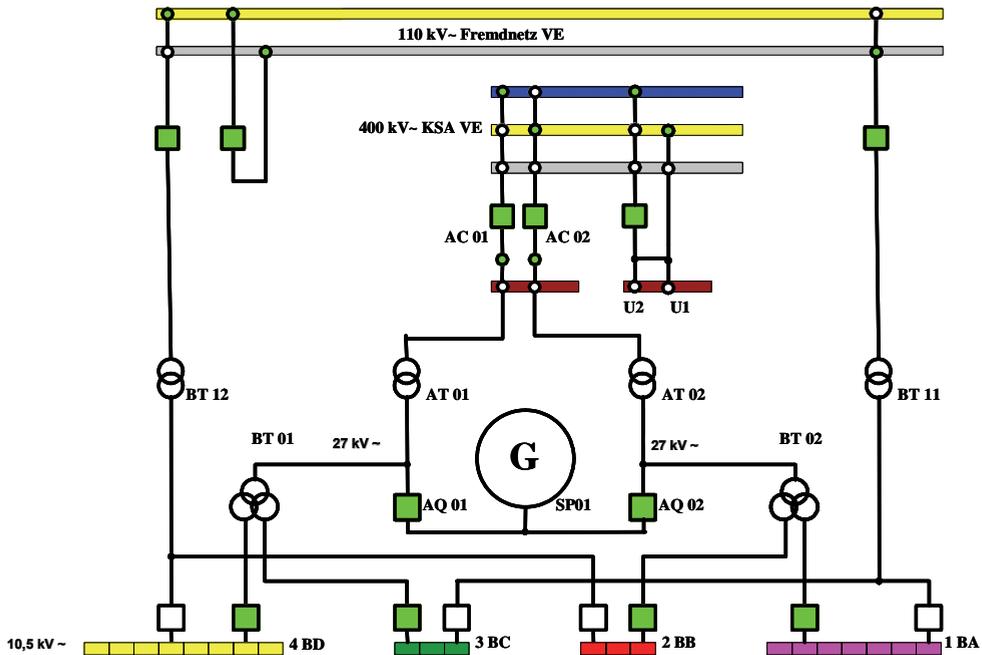
Fig. 7. Simplified diagram of the station service supply and the grid connection of the nuclear power plant

At the same time, de-excitation of the generator was actuated. The short circuit was thereby isolated. In addition, two of the four station service supply bus bars (3BC and 4BD) were switched to the 110 kV standby grid (VE). A simplified diagram is given in Figure 7 (Berg & Fritze, 2011).

Within 0.5 s, the generator protection system (initiating 'generator distance relay' by remaining current during de-excitation of the generator which still feeds the shot circuit) caused the second circuit breaker between the 380 kV grid connection and the intact generator transformer (AC02) to open. Subsequently the two other station service supply bus bars (2BB and 1BA) were also switched to the standby grid. After approx. 1.7 s, station service supply was re-established by the standby grid.

To end the short circuit, the differential protection system of the generator transformer caused to open the circuit breaker between the 380 kV grid connection and the affected generator transformer as well as the generator circuit breaker to the unaffected transformer.

opening of the circuit breaker between the second 380 kV grid connection and the remaining intact generator transformer is caused by the remaining current after de-exciting the generator which initiates the distance relay of the generator protection system.

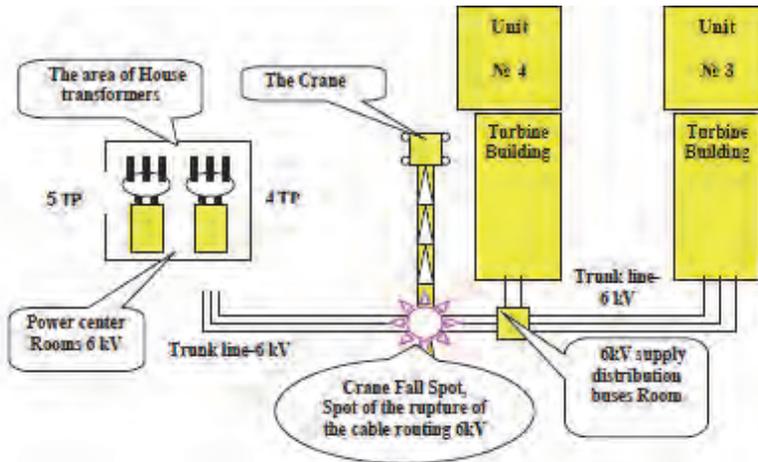
Fig. 10. Diagram of the situation after the event (from IAEA, 2004)

The event started when the jib of the crane fell on the trestle with the cables passed from 330/6 kV transformer TP 4 and TP 5 to unit 4 and broke them. The cables fell on the ground. The diagram of the situation after the event is provided in Figure 10 (IAEA, 2004).

There was a loss of normal and emergency auxiliary power supply which resulted in a decrease of the frequency of the power supply buses of the main coolant pumps. The emergency protection was actuated and the reactors of units 2 and 3 were scrammed. The long-term exposure of this earth fault (1 min and 36 sec.) caused a high earth fault currents which burn the cables. This led to a fire spread to the 6 kV supply distribution buses and 6 kV metal clad switchgear rooms resulting inside these rooms in high temperature and release of the toxic substance. Also the equipment of the transformers TP 4 and TP 5 was damaged.

The earth fault has to be disconnected with differential protection of the line 330 kV but it was actuated with the output relays of the TP 4 and TP 5 which was damaged.
